**GOD'S LITTLE ACRE  
NEWPORT COMMON BURIAL GROUND  
NEWPORT, RHODE ISLAND  
TREATMENT REPORTS FALL 2025-SUMMER 2026**

**CONSERVATION TREATMENT REPORTS  
FALL 2025-SUMMER 2026  
WORK SEASONS**

Francis Miller, Conservator, PA AIC  
Conserve ART LLC

August 17, 2026

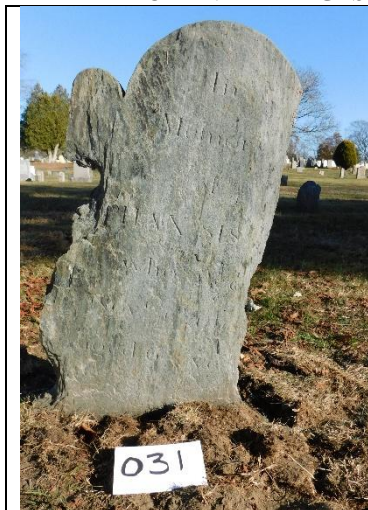
GLA 031 1. BT. Front overview.

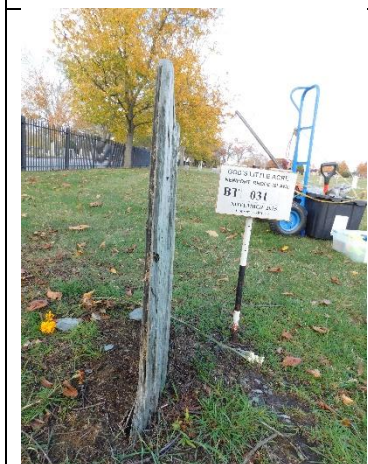
GLA 031 5. BT. PR overview.

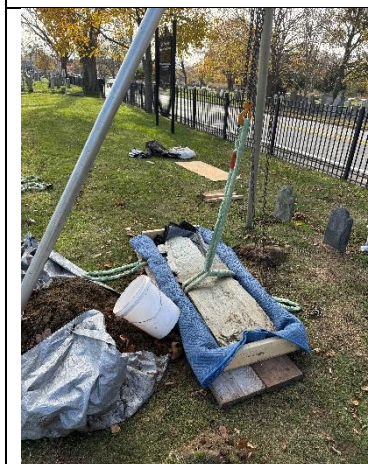
GLA 031 9. DT. Setting marker in wood crate.

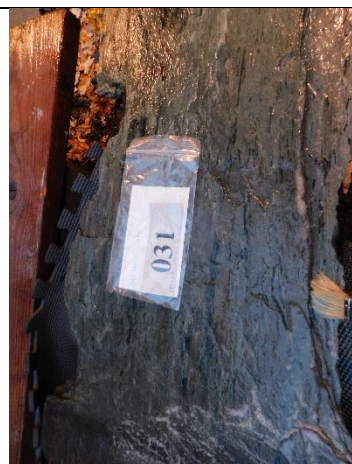
GLA 031 10. DT. Cleaning cracks with Orvus and water.

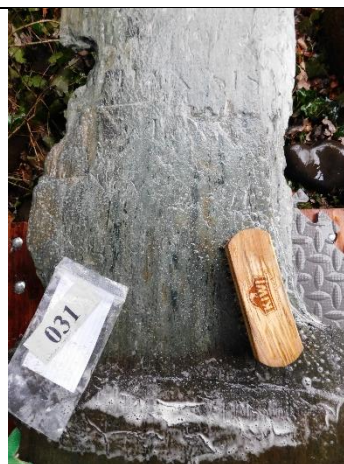
GLA 031 11. DT. General cleaning with Orvus and water.

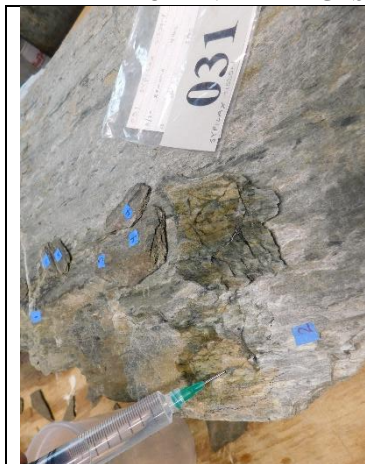
GLA 031 13. DT. Adhering fragments with B-72.

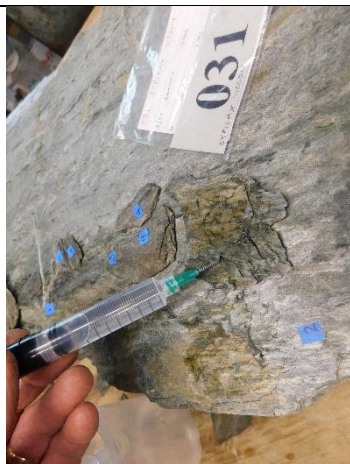
GLA 031 14. DT. Adhering fragments with B-72 and injecting cracks in fragments.

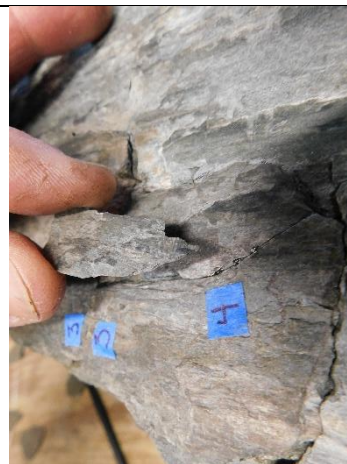
GLA 031 15. DT. Adhering fragments with B-72.

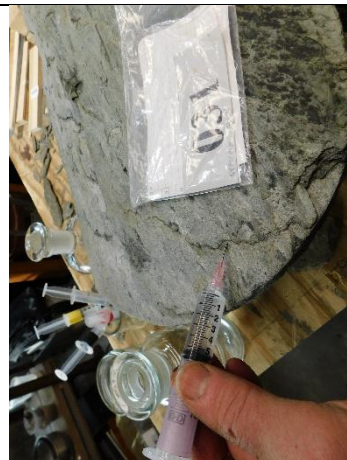
GLA 031 19. DT. Injecting cracks with B-72.

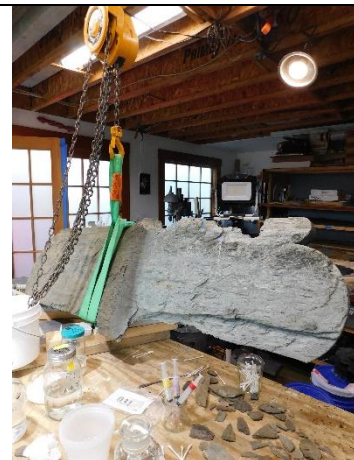
GLA 031 20. DT. Rigging marker for B-72 injections in cracks.

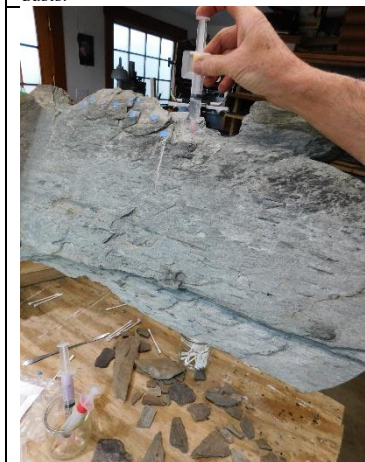
GLA 031 21. DT. B-72 injections in cracks.

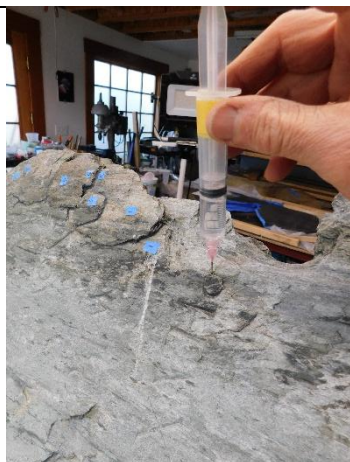
GLA 031 22. DT. 20% B-72 injections in cracks.

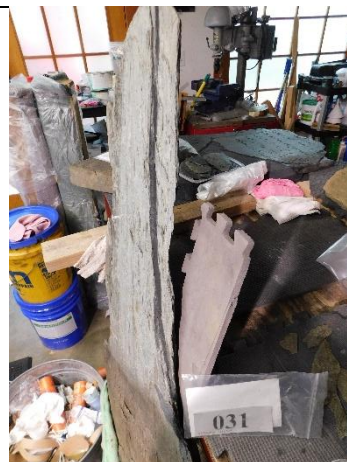
GLA 031 23. DT. Fills along cracks with Edison Coatings Systems 45 and slate aggregate.

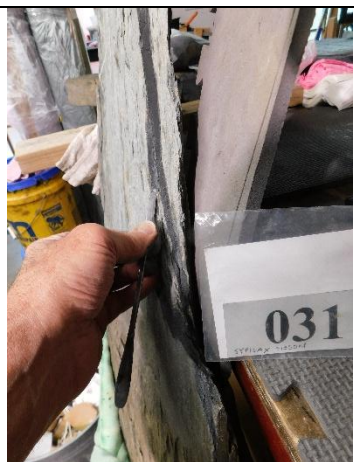
GLA 031 24. DT. Detail of fills with Edison Coatings Systems 45 and slate aggregate.

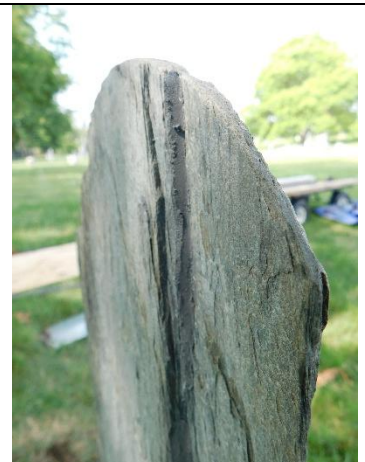
GLA 031 32. AT. Detail of crack and fill on face.

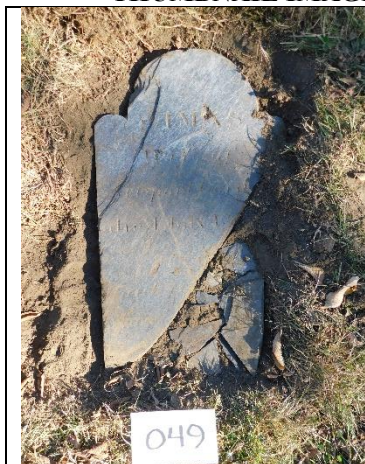
GLA 049 1. BT. Top overview while unearthing fragments.

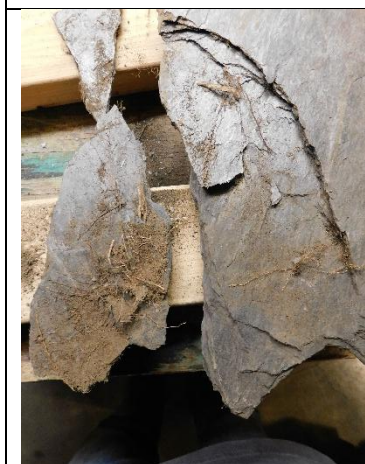
GLA 049 9. DT. Separating cleaved fragments filled with roots before cleaning.

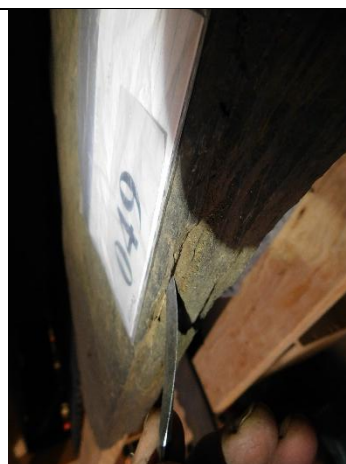
GLA 049 11. DT. Removing roots and earth between cleavage cracks before water contact.

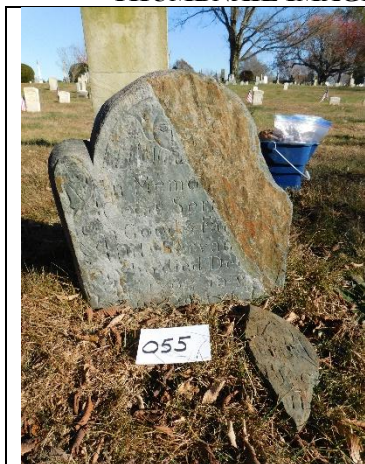
GLA 055 1. BT. Front overview.

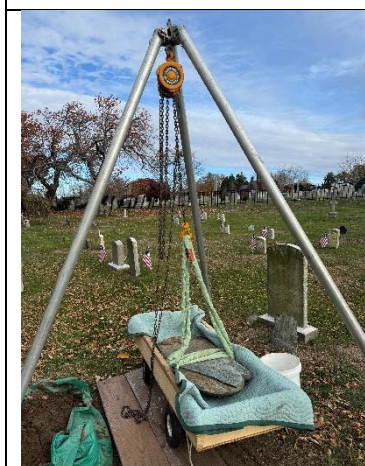
GLA 055 9. DT. Setting marker in wood crate.

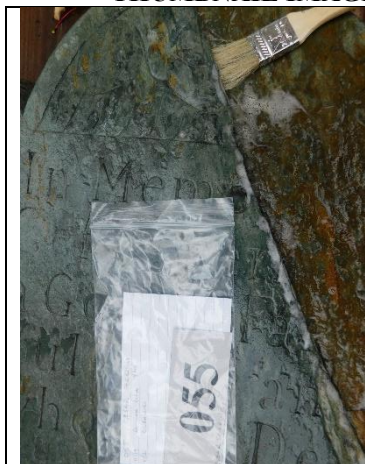
GLA 055 13. DT. Cleaning cracks with Orvus solution.

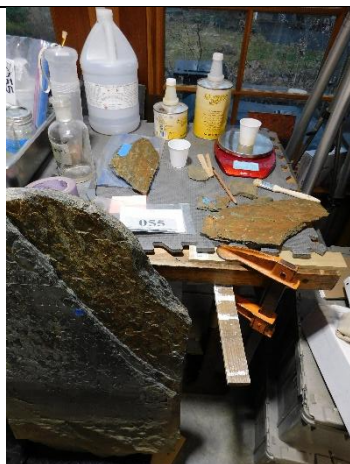
GLA 055 14. DT. Adhering face fragments.

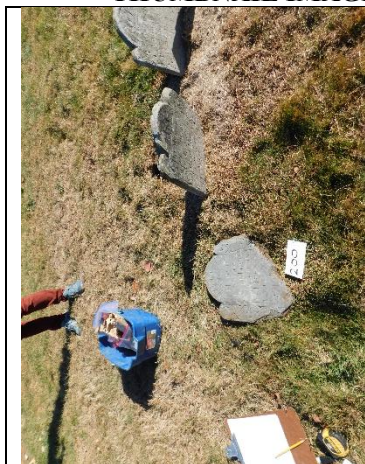
GLA 200 1. BT. Front overview of marker and location.

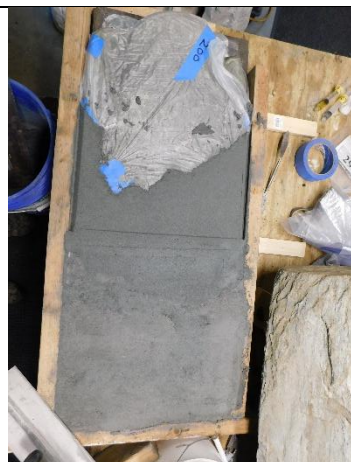
GLA 200 6. DT. Casting missing section with Edison Coatings Systems 45 and Marine Latex.

■ **Loss Replacement:** The lower section was cast with Edison Coatings Systems 45 using Marine Grade Latex and tinted with Bayferrox pigments. The thickness was oversized with the back extending further for additional strength of the composite material. The cast lighted considerably after curing and requiring the visible portion to be stained with a darker slurry of the same casting material. The cast was joined with Akemi Akepox 2030 Epoxy tinted with Akemi Coloring Paste.

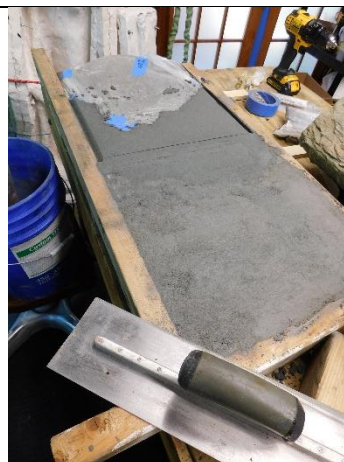
GLA 200 7. DT. Finishing cast section with Edison Coatings Systems 45 and Marine Latex.

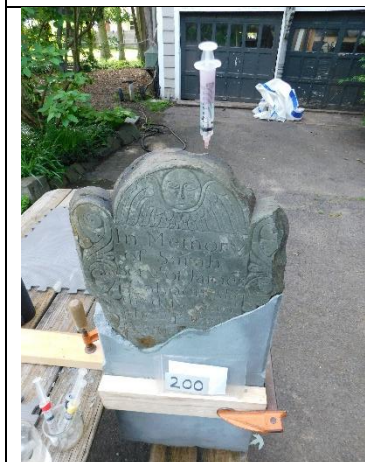
GLA 200 9. DT. Injecting upper cracks with B-72.

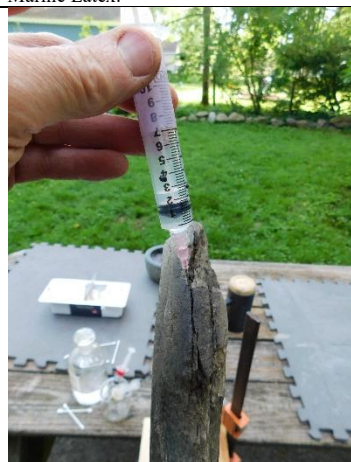
GLA 200 10. DT. Injecting upper cracks with 5% B-72.

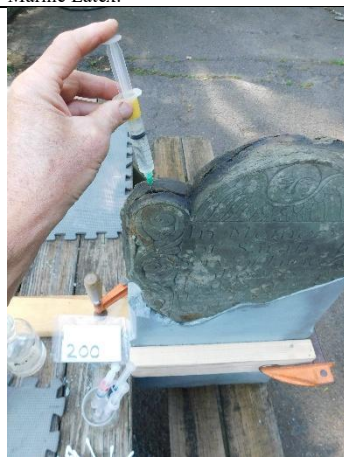
GLA 200 11. DT. Injecting upper cracks with 20% B-72.

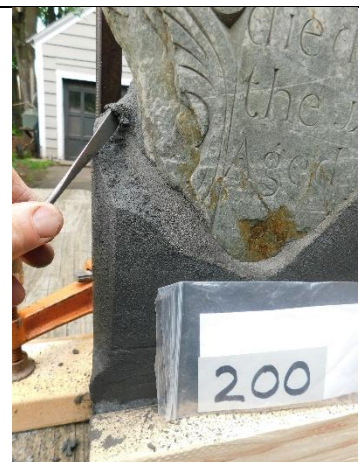
GLA 200 12. DT. Filling mend-lines and caps with Edison Coatings Systems 45 and slate dusts.

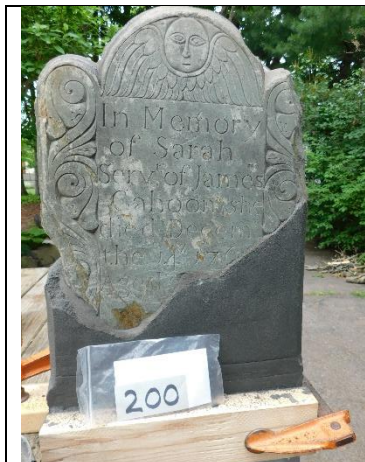
GLA 200 13. DT. Front view after fills and staining of cast section.

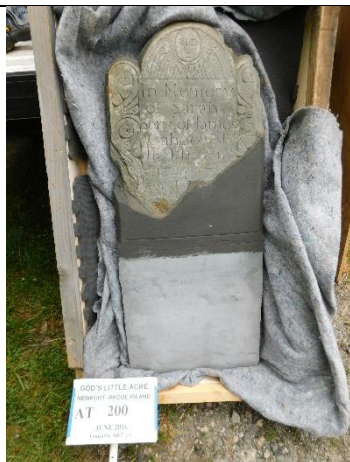
GLA 200 14. DT. Marker in crate showing stained caste section with Edison Coatings Systems 45 and Marine Latex

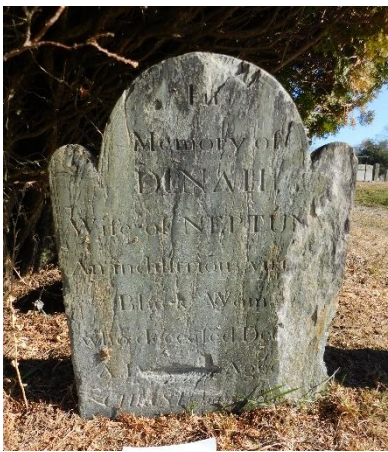
| <p><b>MARKER CONDITION</b></p> <p>■ <b>Growth/Soiling:</b> The surface has only minor growths or possible attached dead growths. Small plates have root growth in the cracks below grade.</p> <p>■ <b>Delamination:</b> The front and back have numerous micro delaminations. The micro separation has caused loss to sculptural detail and speckled coloration by exposing "fresh" stone in contrast to an aged surface patina. Macro separations can be clearly seen on the sides and top of the maker. Macro delamination is causing more severe cracking on the sides.</p> <p>■ <b>Cracks:</b> Cracks are formed along the delamination. Larger cracks are visible on the top and sides, particularly at impact points and breaks.</p> <p>■ <b>Breaks:</b> The proper left has impact breaks where the side and face have fragmented in numerous pieces. The top also has impact breaks and associated cracks.</p> <p>■ <b>Losses:</b> Shallow losses through out and major losses at impact points on the proper left side top and on the proper right shoulder. The death date has been gouged out and is lost.</p> <p><input type="checkbox"/> <b>Hazardous Alignment:</b></p> <p>■ <b>Other:</b> The evergreen shrub behind the marker has overgrown the stone.</p> | | |

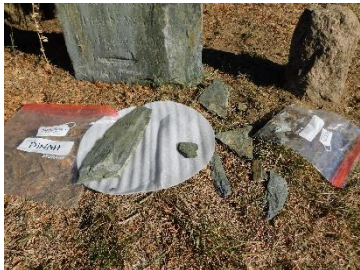
| <b>Dimensions:</b> H: 21/50    W: 16    D: 2 | Front overview before treatment | Fragments from the proper left side. |

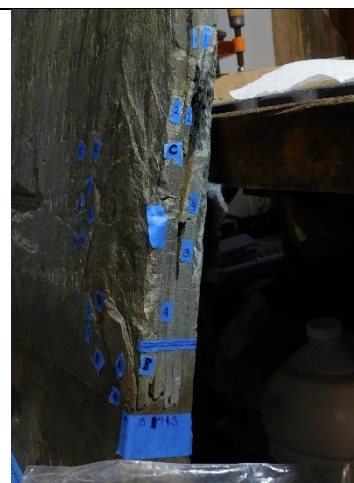
GLA 275 8. DT. PL dry fitting fragments.

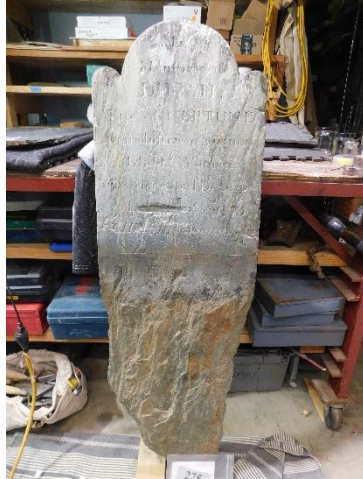
GLA 275 14. DT. Overview of marker after fills.

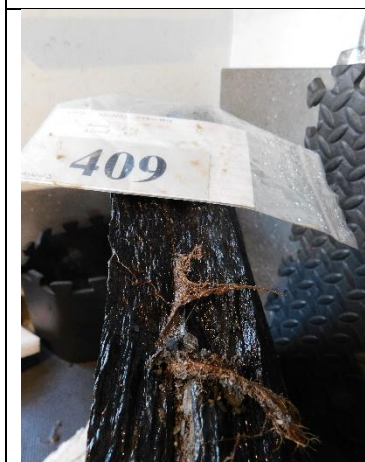
GLA 409 5. DT. Lower section with roots in cracks.

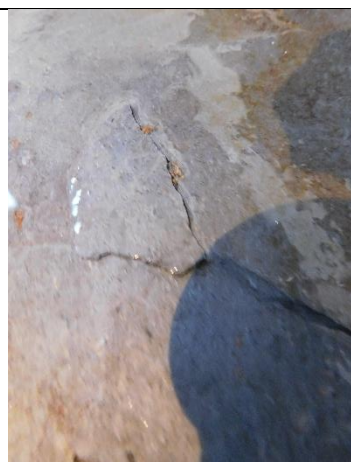
GLA 409 6. DT. Small fragment held by roots.

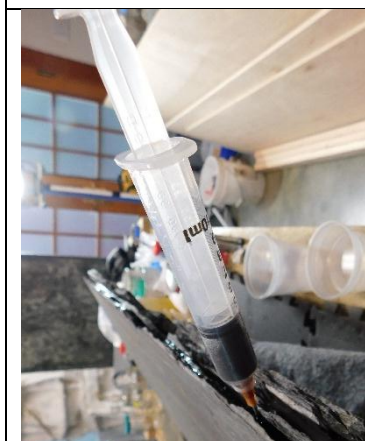
GLA 409 9. DT. Injecting cracks with B-72 and slate dusts before epoxy mending.

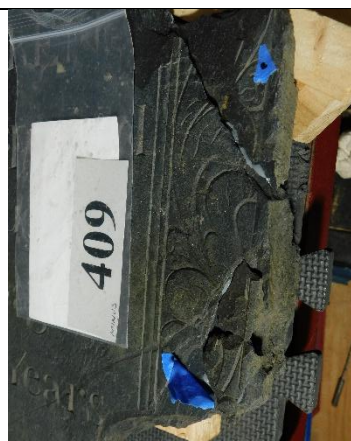
GLA 409 10. DT. Bonding fragments with Akemi Akepox 2030.

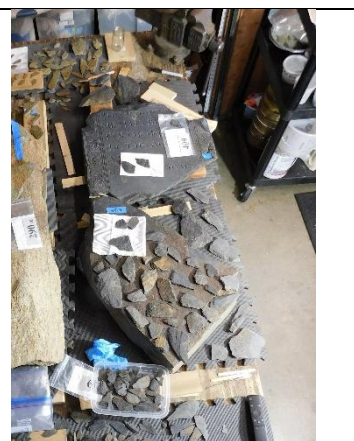
GLA 409 12. DT. Checking fragments for fit before casting loss replacement.

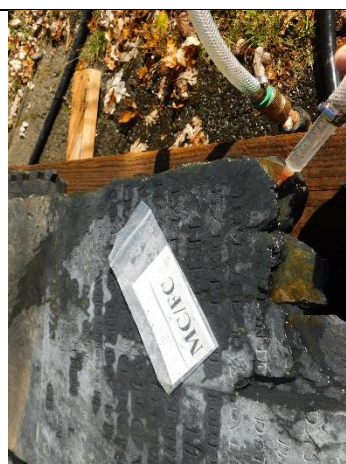
CBG MC-FC 11. DT. Flushing cracks with pressurized water.

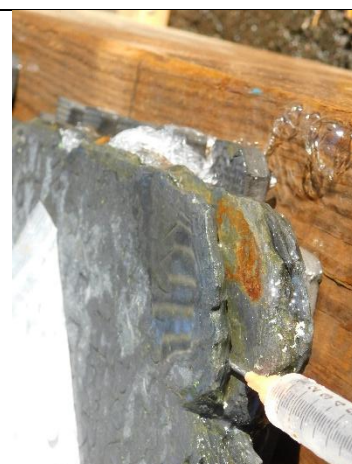
CBG MC-FC 12. DT. Flushing cracks with pressurized water.

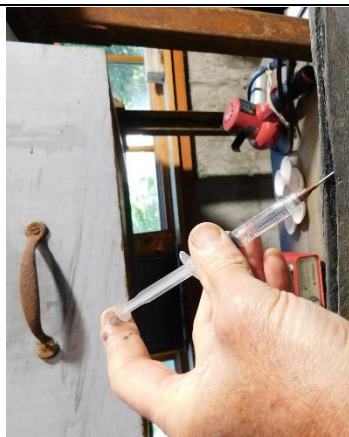
CBG MC-FC 14. DT. Injecting cracks on sides with B-72.

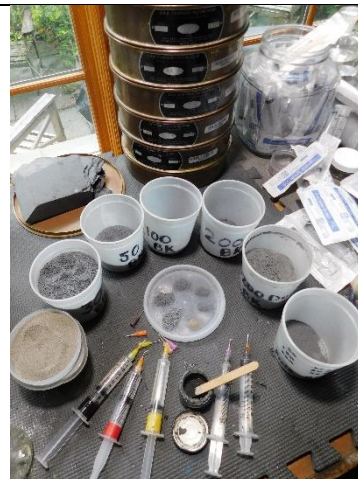
CBG MC-FC 15. DT. B-72 solutions and bulked with state dusts and ceramic spheres. (2)

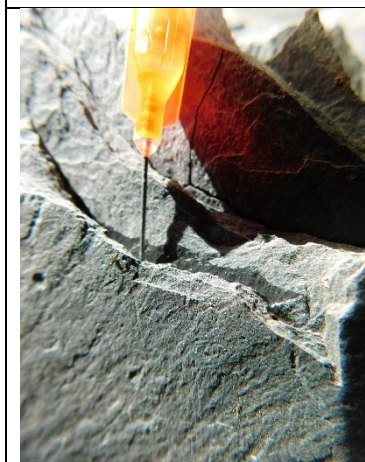
CBG MC-FC 17. DT. Injecting cracks with B-72.

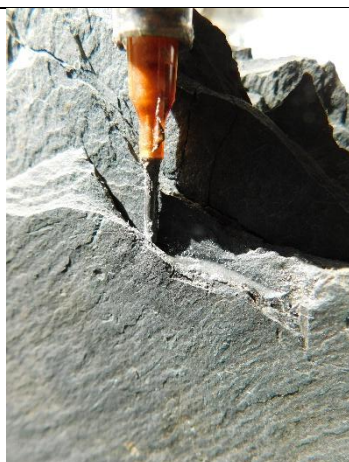
CBG MC-FC 18. DT. Additional injections and caps with B-72 and slate dusts.
