God's Little Acre Condition Assessment Final Report

March 2022

For:
Giles Eyre
GLAPP Foundation

By:
Amanda Trienens
Cultural Heritage Conservation LLC

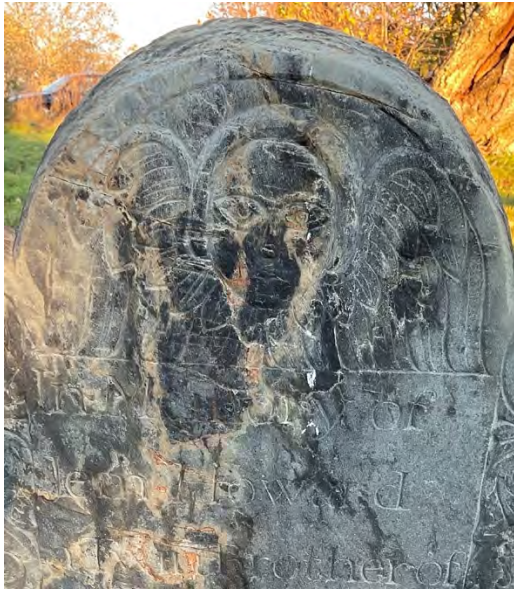
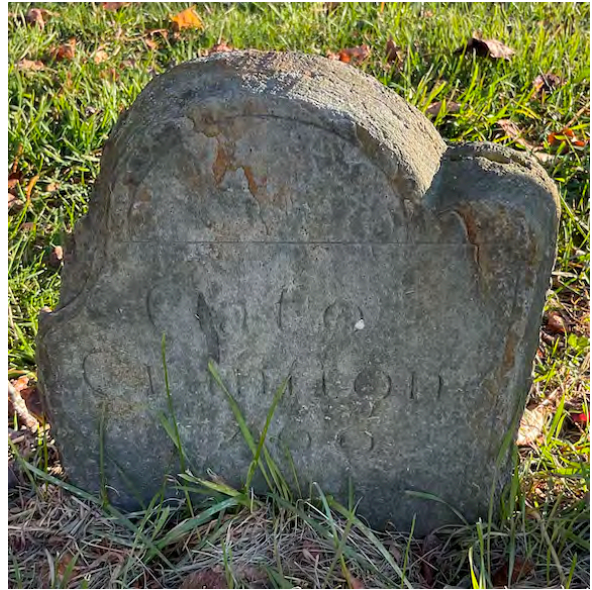
Markers 411 (left) and 290_fs (right) have delamination occurring at the interface of an iron-rich bedding later.

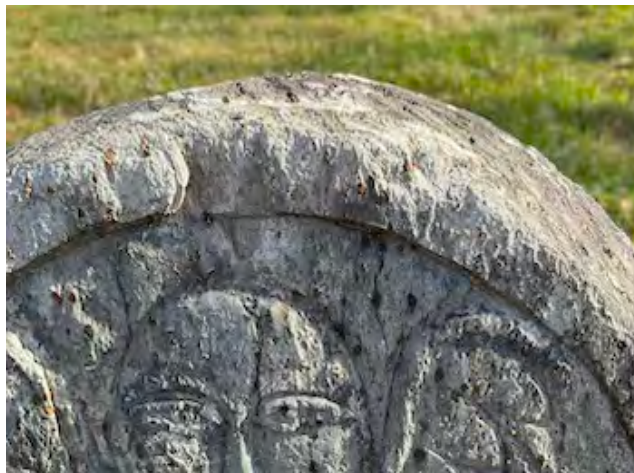
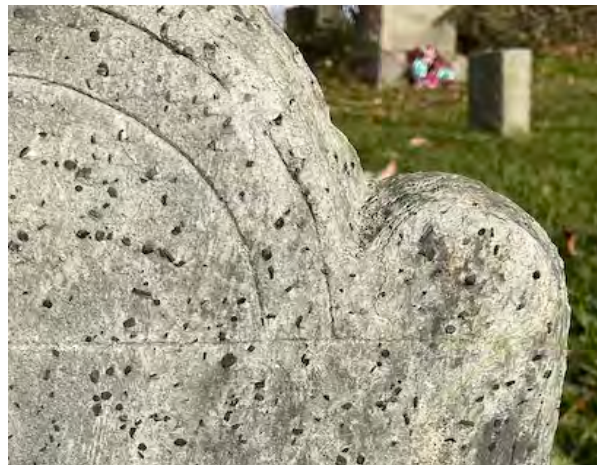
Markers 202 (left) and marker 289_fs (right) are two different slate varieties with prominent iron-rich mineral inclusions.

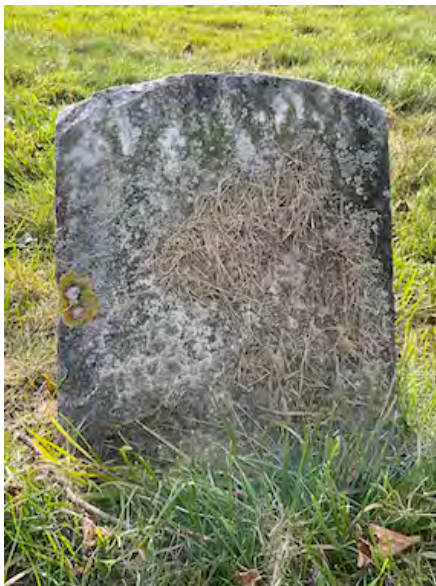
Marker 295 exhibits black biogrowth and matted grass clippings.

→ Guidance on treatment: Since there was a recent cleaning campaign of the slate markers at GLA, the reduction of biological growth is not an urgent treatment need, but primarily an aesthetic choice. A maintenance plan that periodically reduces the accumulation of biofilms and biogrowth is however recommended. The maintenance schedule is site specific, but GLA should be assessed for potential cleaning in three years. It is recommended in the future to spray apply D/2 and allow the elements to do the remainder of the cleaning. It is not recommended to scrub the grave markers as the flaking and erosion observed on a significant number of them illustrates their fragility.

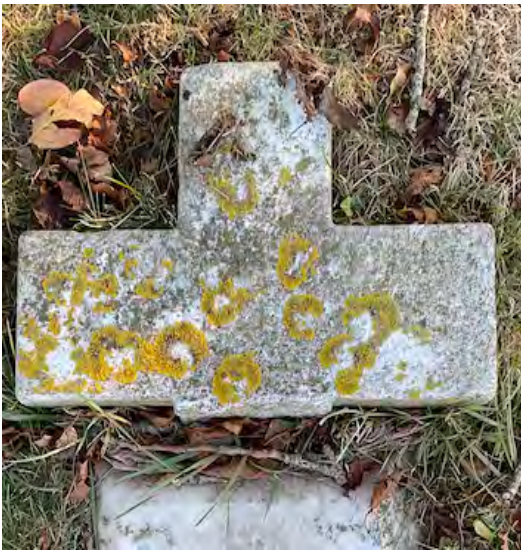
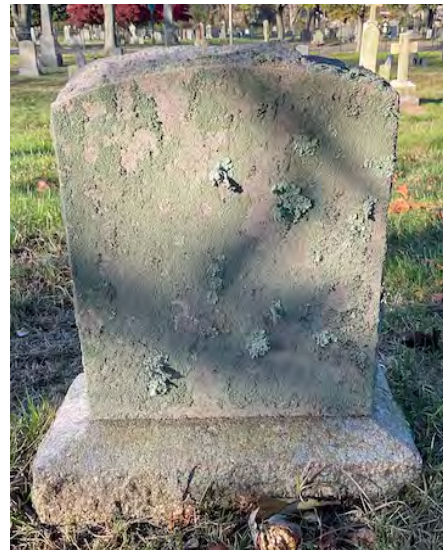
Markers 285 (left) and 286 (right) with layers of lichens associated with other biogrowth.

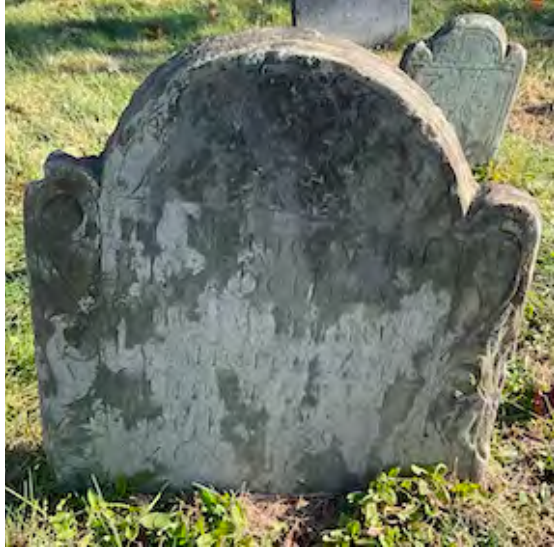
Because of the chemical exudes, some acidic, from the respiration of biogrowth, and the mechanical force of their cellular growth between mineral crystals, biogrowth is generally considered a risk to stone, best removed. Due to compositional differences the stone varieties are affected differently by the chemical effects, with marble more vulnerable than slates and granites. Because of both chemical and mechanical action on stone surfaces, microscopic etching and roughening of surfaces occurs, and as mineral crystals are fractured, localized alteration in appearances result. Heightened texture of surfaces can increase the hospitable environment for biogrowth, so once established, biogrowth propels a cycle of stone deterioration and increased biological population. When advanced to dimensional scales, biological growth can cause disaggregation, spalling and fragmentation. At GLA there was no evidence of this scale of active damage. However, the differential erosion of marble and slate surfaces may indicate the impact of biogrowth now removed. Examination of surface samples by advanced microscopy could confirm that the contrast of surface appearances on Marker 398, for instance, was produced in this manner.

The contrast in surfaces of Marker 398 may reflect damage from biogrowth, though this would require further study to confirm.

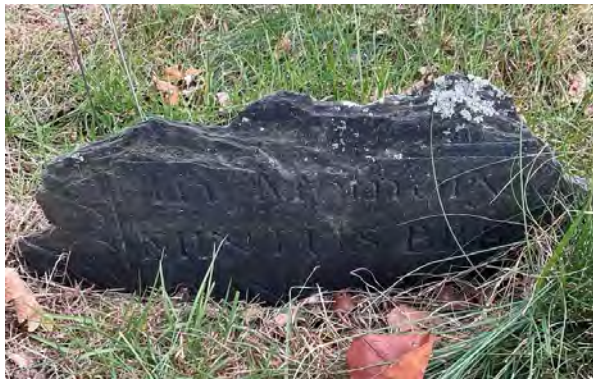
Marker 409 was intentionally buried because much of its lower half is missing so it no longer has the support for the above-ground portion of the marker.

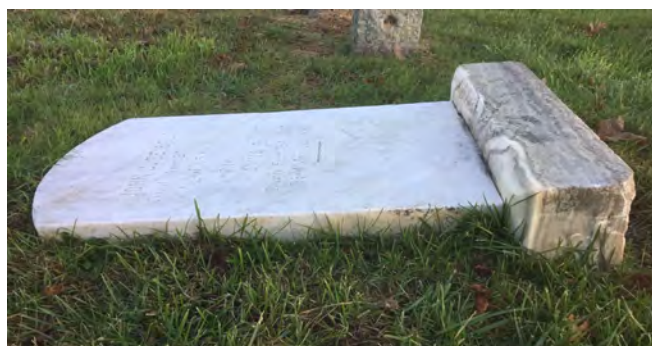
Marker 139 – the marker has fallen over due to unknown reasons. This would be a high priority to reset because there are new stresses and pressure points on the marker that may cause greater damage in the future.

→ Guidance on treatment: The area where the marker is to be set should be dug approximately 4" deep, filled with 1" to 1.5" diameter gravel and tamped down to provide drainage. The marker should be set in place slightly nestled in the gravel and ensured that it is level and stable. The gravel can be covered with a mixture of smaller gravel and dirt or the existing sod, but it is recommended there is a berth of one foot around the perimeter of the marker at a depth of 4" of gravel to protect the marker from landscaping equipment and allow for drainage.

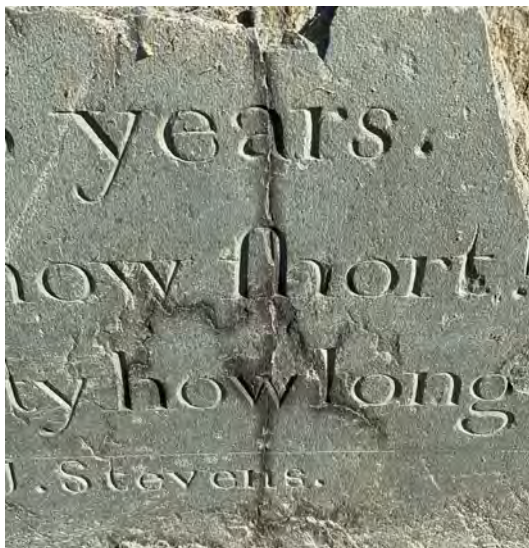
Marker Unlisted (252) exhibits cracks in slate that hold the moisture of the morning condensation. These are related to delamination but present differently as they traverse down the front flat plane of the slate.

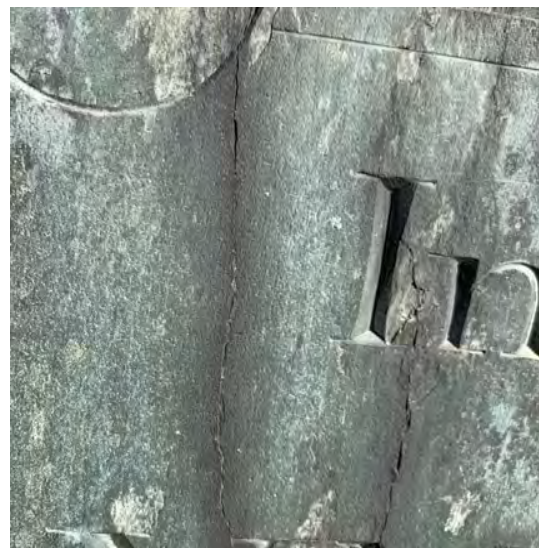
Marker with cracks that are too thin to fill. The dark discoloration on either side of the cracks is not moisture as in the image on the left but soiling that is attracted to the moisture the cracks hold.

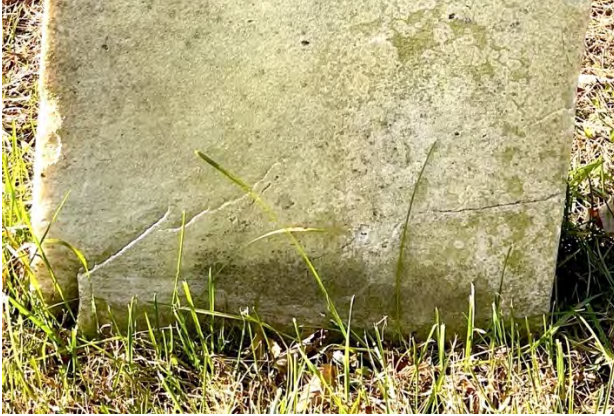
In some cases, cracks appeared to be from impact because they were located at the corners of bases or edges of markers perhaps from landscaping equipment and work (Marker 70).

Marker 70 cracks in marble that require repair before additional loss of material results

→ Guidance on treatment: If cracks are 0.6mm wide or larger they can be filled with a crack filler such as VoidSpan 400 Series PHLc70 Crack Filler colored to match stone. If cracks are deep, they can be injected with a compatible grout, such as VoidSpan 600 Series PHLc70 Injection Grout, through drilled portholes or deep fissures along the crack.

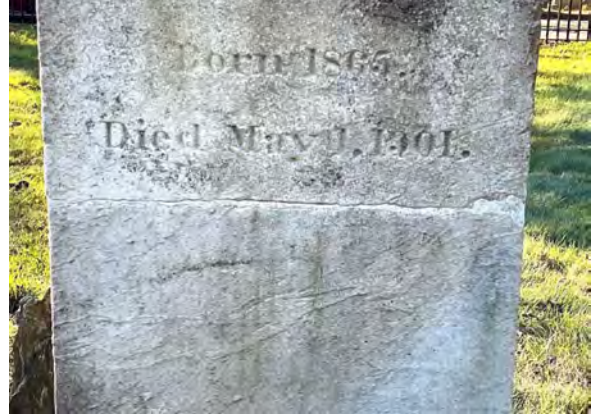
Marker 54 with a repaired crack/fracture, but entered as Previous Repair in the database.

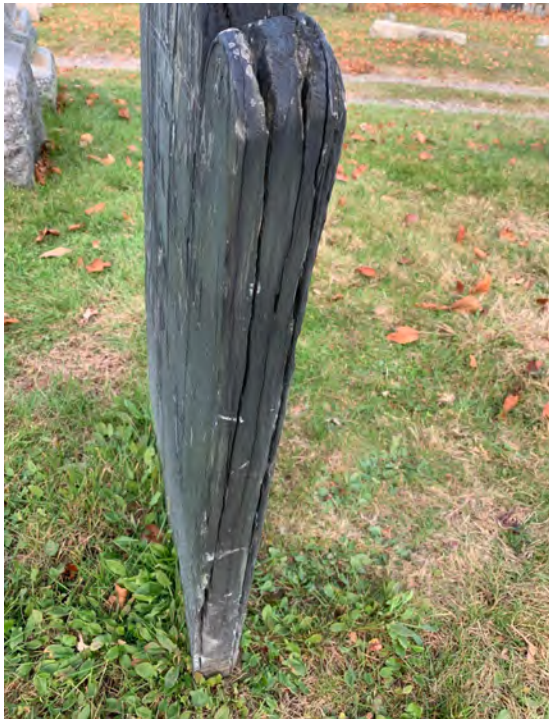
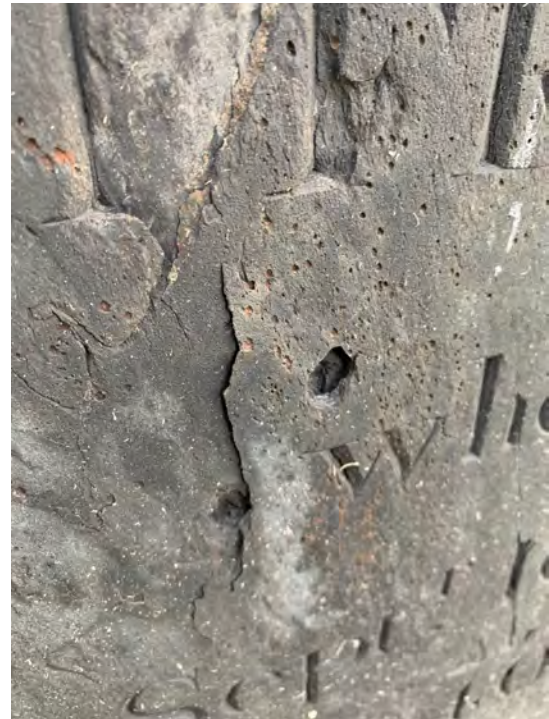
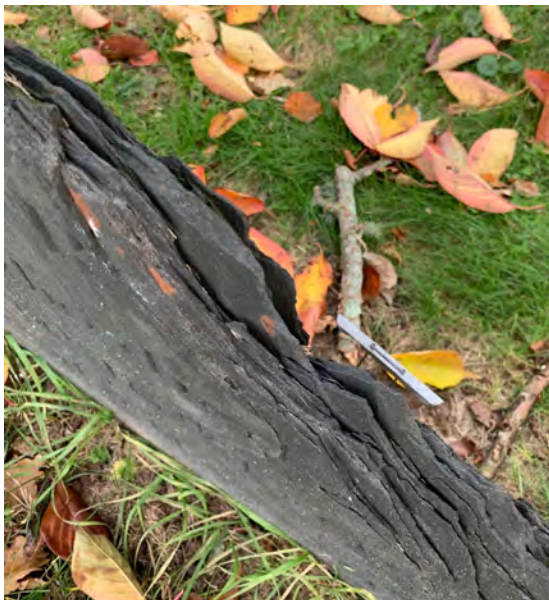
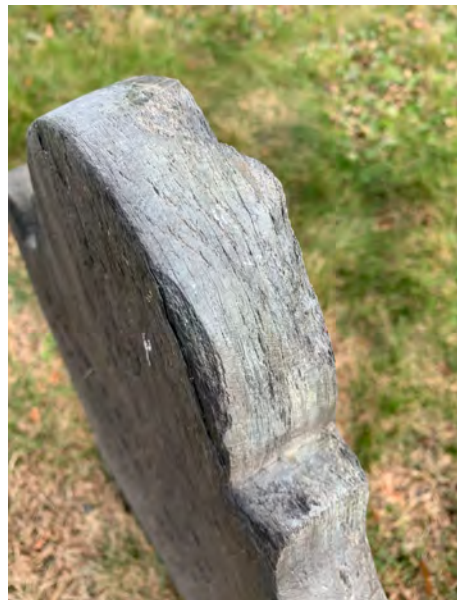
Examples of Priority I Delamination. The bottom right image depicts a grave marker that does not have a number of voids to fill and largely the top delamination is densely packed however there is a small area of delamination on the front that threatens the inscription and is wide enough to receive a fill. This could also be a candidate for a cap due to the intact nature of the top of the grave marker.

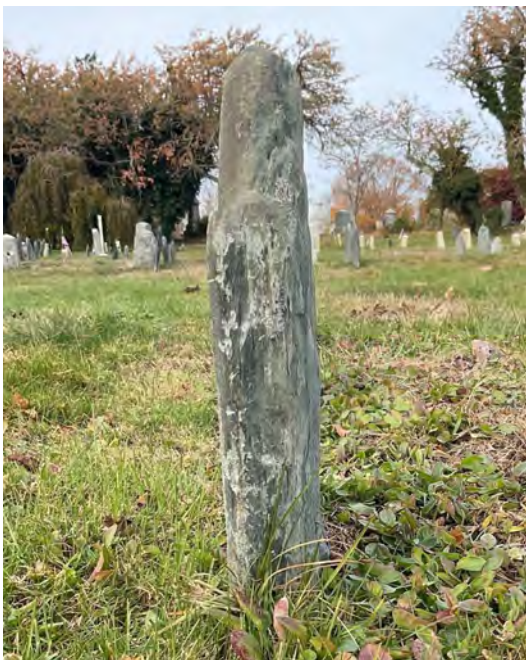
Example of Priority 4 Delamination – there are no treatable areas but the condition is extant.

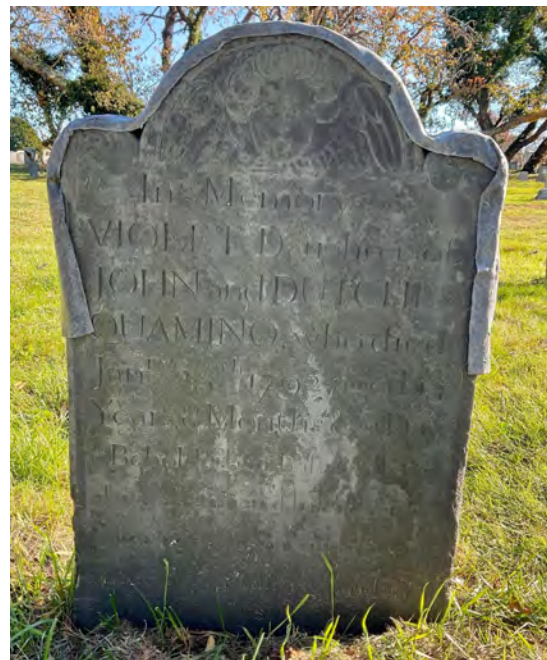
There is one grave marker at GLA that currently has a cap (Marker 9) but it is somewhat poorly executed and was noted to be failing because two breaches were observed in the lead. Archival images depict other markers having had metal caps in the past, but it is not known when and why they were removed.

Marker 9 is currently the only gravestone that has a lead cap on it. This cap is breached in two locations so it is recommended to remove and perhaps re-cap depending on the condition of the slate underneath it. This is a viable repair option when caps are fitted and customized to each marker.

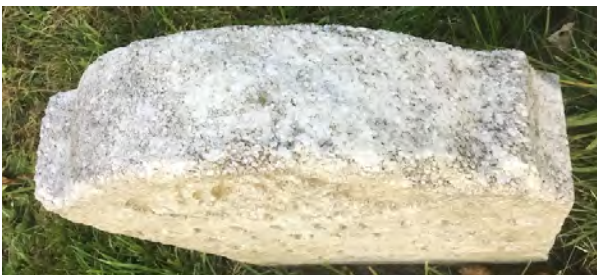
Marker 461 has the highest of all markers Severity 2 for Disaggregation.

→ Guidance on treatment: At this time no treatment is recommended for disaggregation except monitoring for changes in Severity. If active sugaring is observed on marble, consolidation may be elected with a commercial product such as HCT followed by Conservare OH100. Consolidation can only be completed in a mild and dry environment above 45F so should be planned in temperate months. The substrate must be cleaned of other contaminants such as biogrowth and atmospheric grime. Application should be completed by an experienced conservator with the proper handling and health and safety precautions.

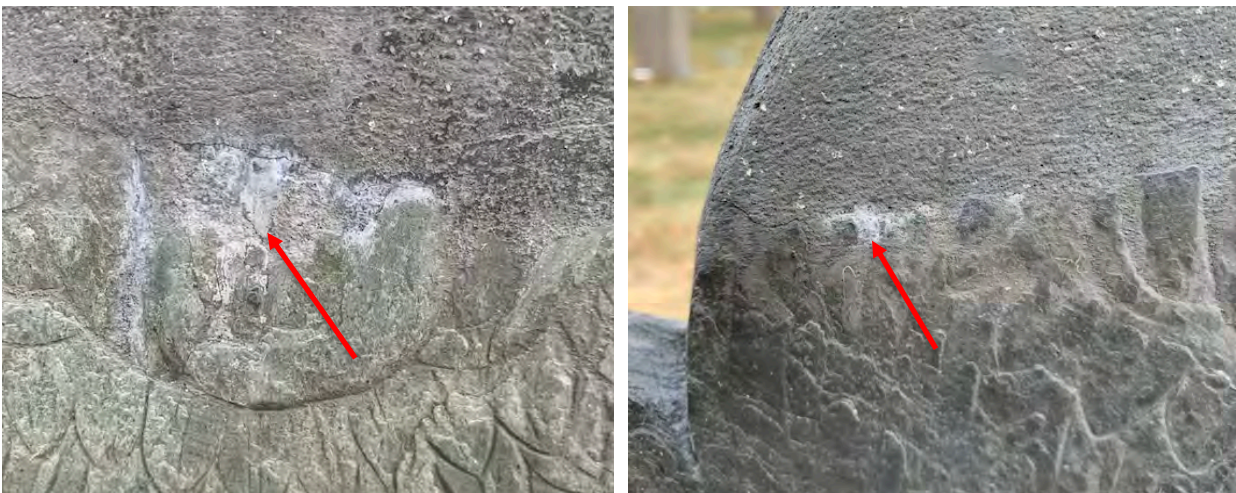
Markers 60 (left) and 81 (right) have efflorescence at the perimeter of a mortar repair.

→Guidance on treatment: Monitor markers for progress of efflorescence and any damage related to it. If efflorescence continues to develop, consider removal of adjacent mortar fill.

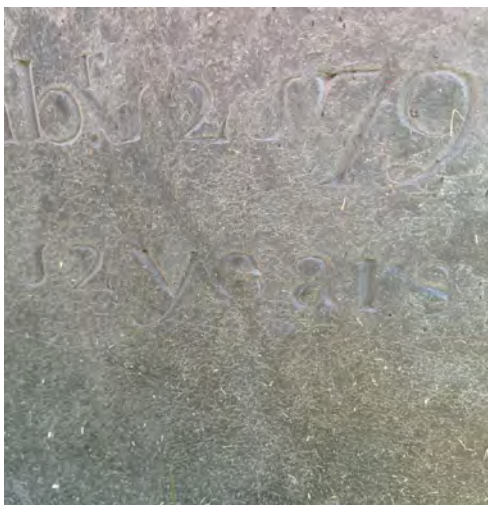
Example of flaked surface where flaking is densely stacked and not treatable. This is designated Severity I because it is on the majority of the front surface.

→ Guidance on treatment: Where there are voids behind flakes that can receive a fill it is recommended to use a custom-colored mortar such as 400 Series PHLC70 Crack Filler or a Jahn product. This would be appropriate for both the slate and marble markers.

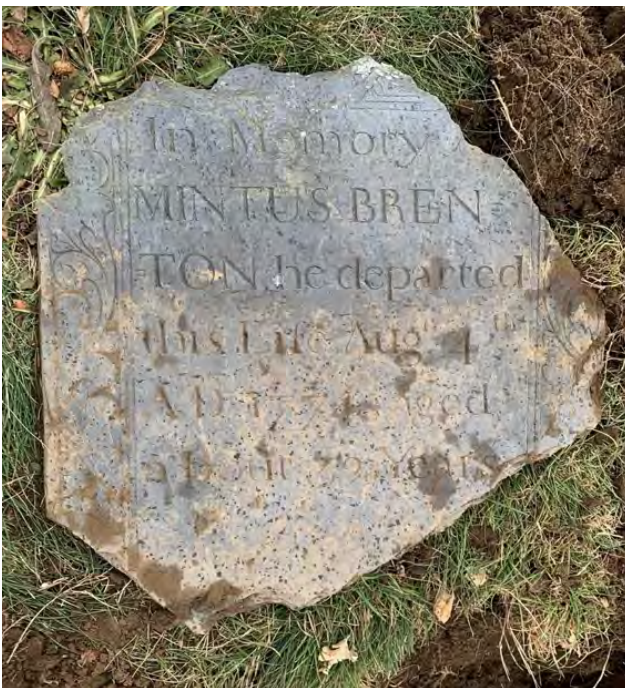
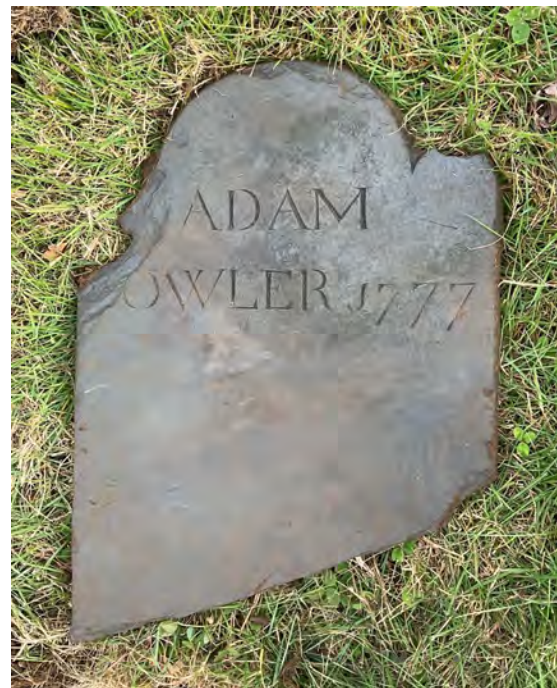
Marker 409 (left) and Marker 300_fs (right) are examples of fragments that can be mounted. There is enough of the inscription remaining to be informative. The fragments should be conserved prior to mounting: this may include stabilizing the edges at their delamination.

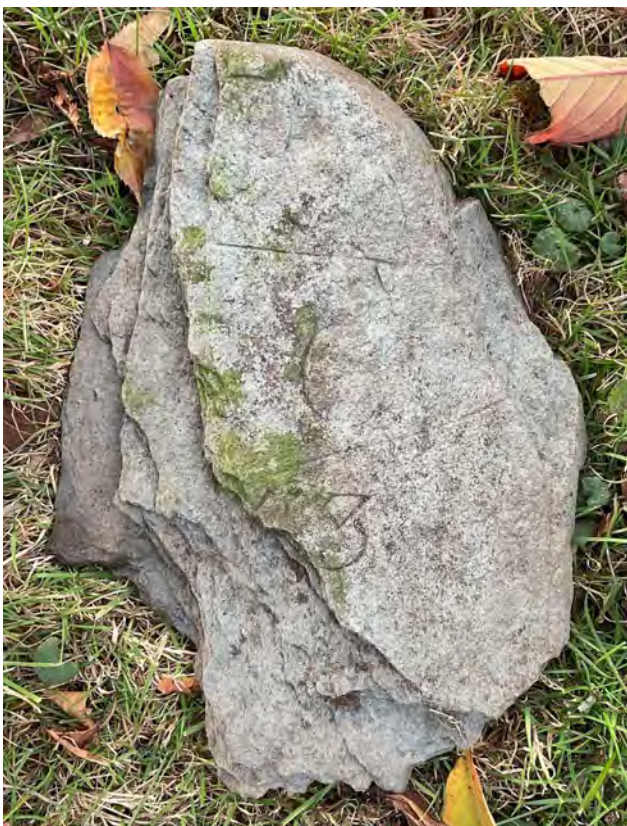
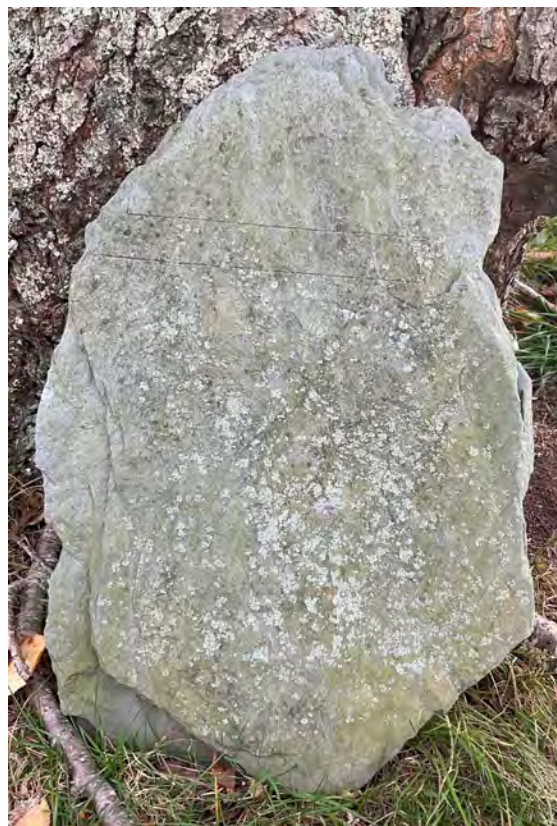
Markers Unlisted (G8) and Unlisted (464) could similarly be mounted if there is archival information known about these markers to aid in their interpretation since there is little inscription remaining. They could also be considered for testing treatments and repairs.

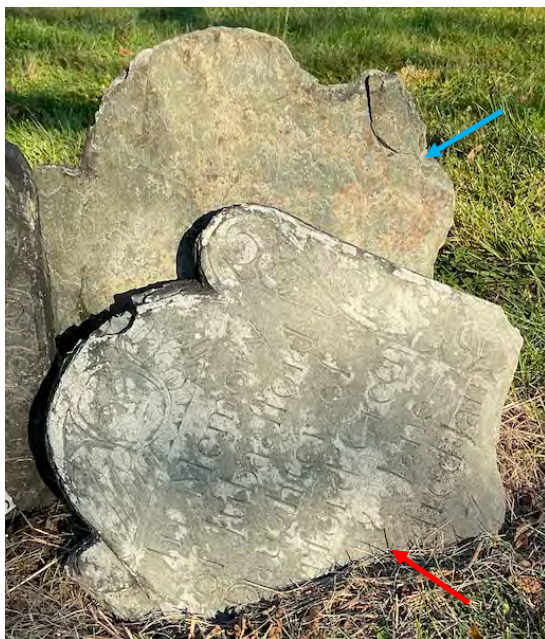
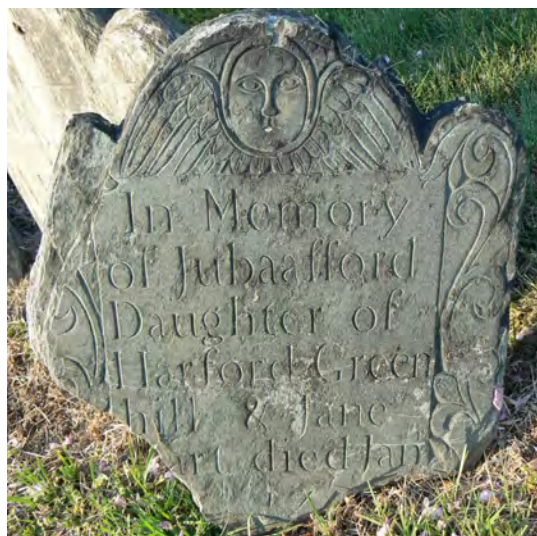
Left: Marker 303 (red arrow) may be fragmented from Unlisted (437) (blue arrow). If that is confirmed then 303 may be able to be adhered to it with epoxy spot welds and fills around the edges. Unlisted (437) may need to be unearthed and laid on a table set up on site in order to ensure a well-executed repair. If digging is too risky straps and clamps with foam protecting the marker can be used to secure the pieces as the epoxy cures. Right: Marker 303 image provided by the client taken in 2008/9. It is in considerably worse condition today.

→ Guidance on treatment: Depending on the configuration, size, and condition of the fragmented pieces they can potentially be pinned back together with appropriately sized and spaced stainless steel pins set in epoxy or mortared/epoxied back together. If there is lacunae after reconstructing those can be filled with a custom-matched mortar patch. If the fragmentation is in slate then the repair for each case needs to be carefully considered. It is not recommended to drill into slate so pinning by conventional methods is not possible. It may be possible to epoxy the pieces back together but it should be done as spot welds and not smeared all over the slate pieces. Ensure the epoxy does not get on the front or back surfaces of the grave stones because it cannot be removed. Once the pieces are secured any voids or cracks can be filled with a custom-matched repair mortar.

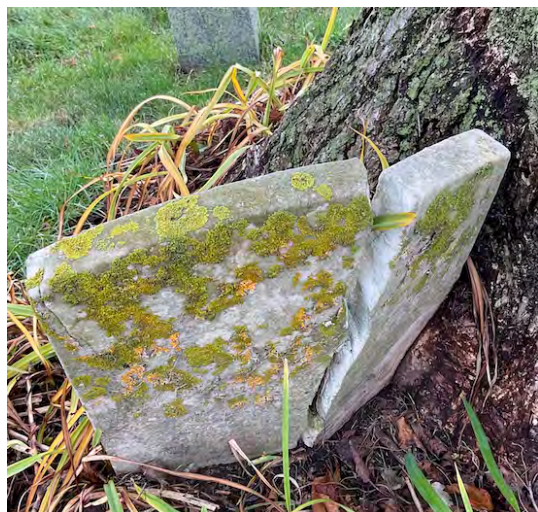
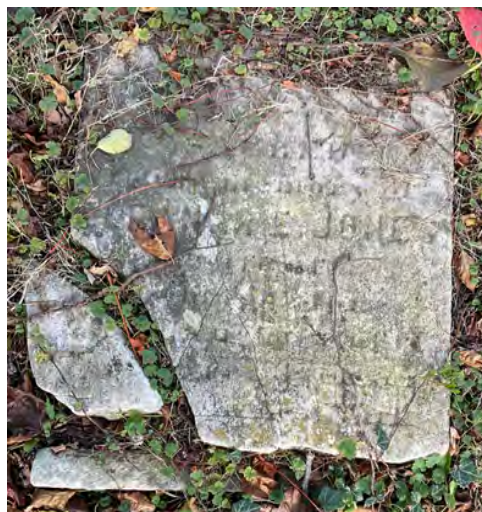
Marker 328 and Marker 145 are fragmented; on the left due to the growth of the adjacent tree and on the right likely because it fell over.

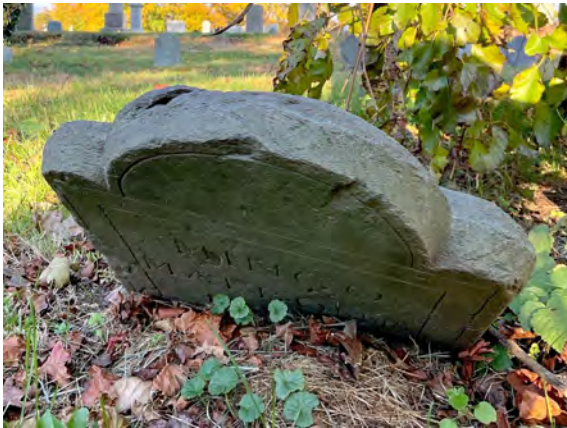
Marker 0003_fs should be reset.

→ Guidance for treatment: The resetting should follow the recommendations made above for the resetting of buried and fallen markers. Excavation of the grave markers should be done with caution.

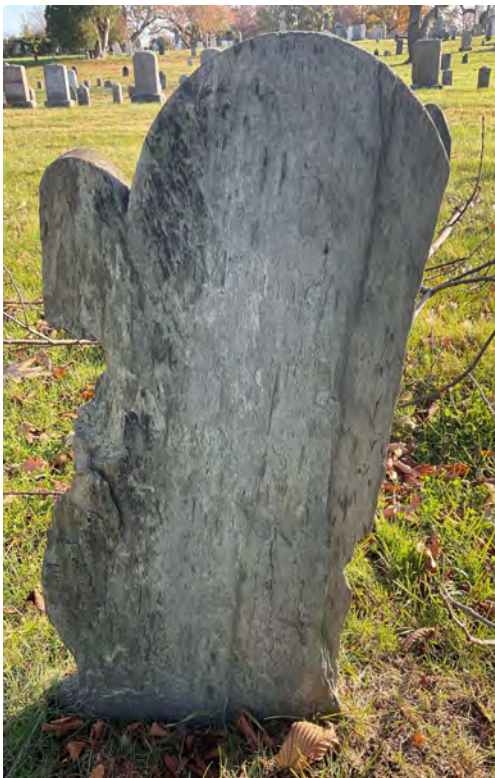
An example of loss typical of the majority of the slate grave markers: parts are missing in their entirety such as the very top of this marker and/or a significant layer of the slate is missing.

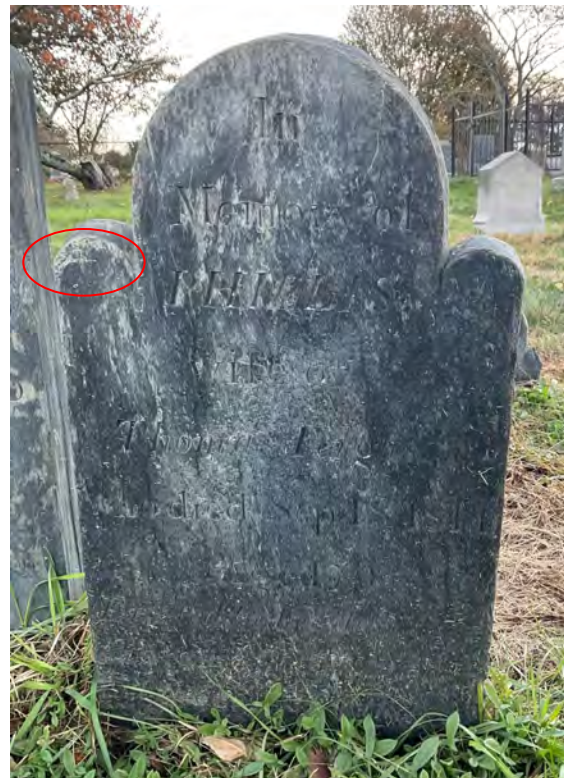
This marker though largely intact exhibits a small loss (red outline) so would still be documented as such in the database.

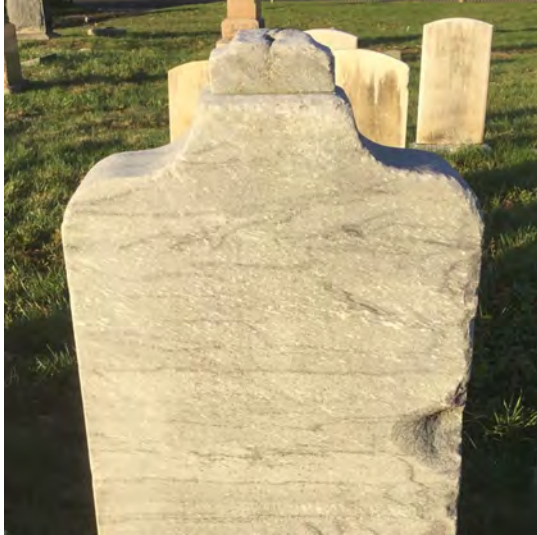
Examples of loss on marble grave markers: the top decorative element is missing (this is known because a pin is revealed) and there is loss on the right edge of the middle of the marker where it has been chipped.

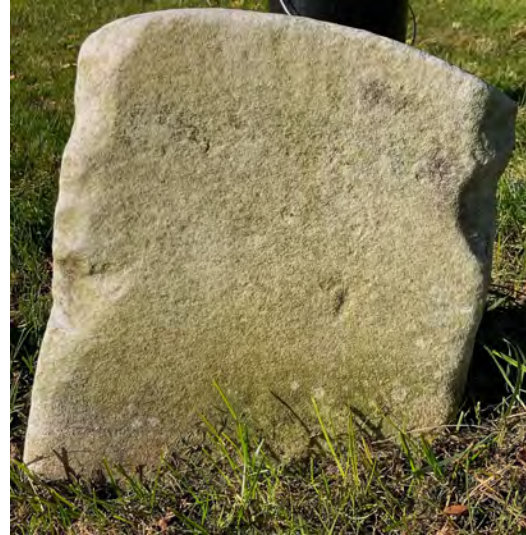
This marble marker exhibits several losses on its edges. Because it is low to the ground it is likely landscaping equipment has repeatedly impacted the marker. The appearance of the loss suggests it is older as it is weathered and soft at the edges.

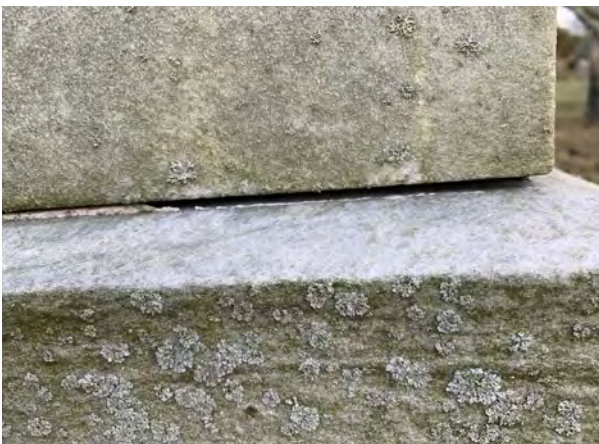
Example of an open joint in marble.

→ Guidance on treatment: To address the open joint the failing mortar should be removed with a 5-in-1 tool or fine masonry chisels, or Dremel bits until only sound mortar remains. A lime- and cement-based mortar custom colored to match the adjacent mortar or stone can be used to repoint the units.

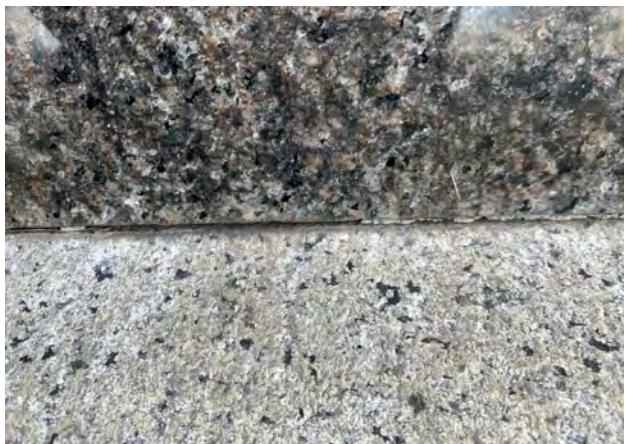
Example of an open joint in granite.

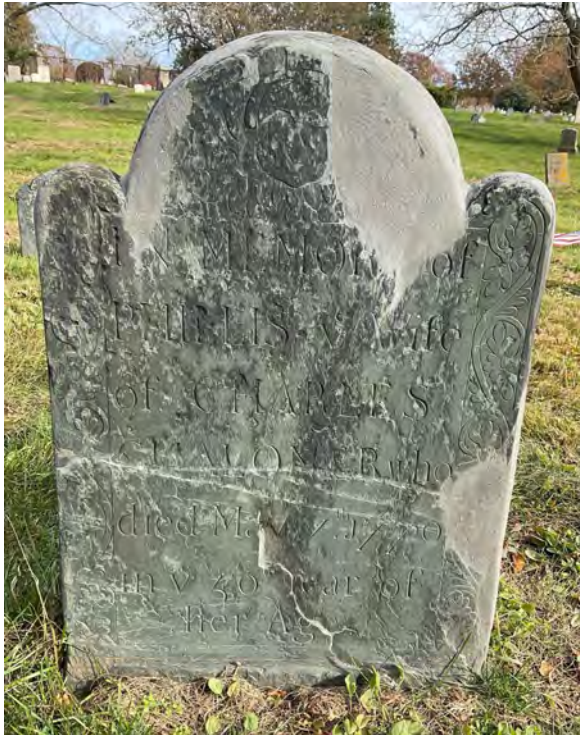
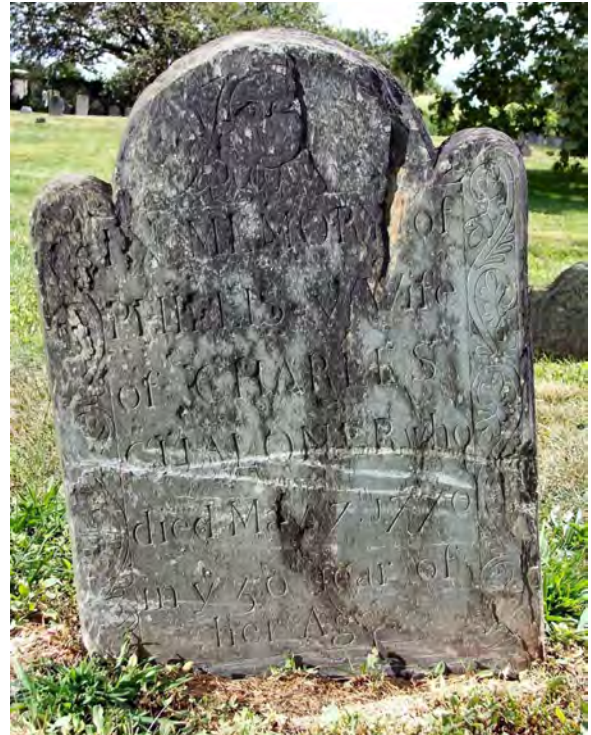
An example of the visually incompatible patching mortar (Marker 72). Looking at images soon after patching (see) it appears as if the mortar never matched the stone well. The fill of the delamination crack at the lower portion of the image represents a good technique for repairing that condition but it should have also been employed in the delamination voids at the edges of the grave marker that instead consist of large areas of fills which are visually jarring and detract from the grave marker and inscription. Right: Marker 72 in 2008.

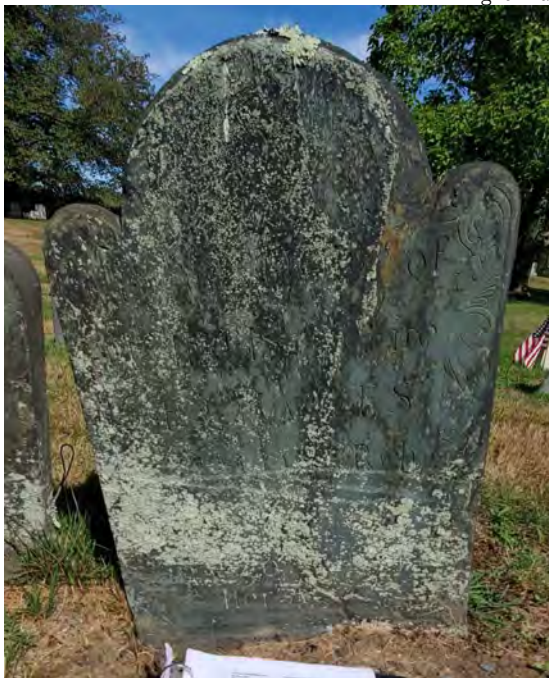
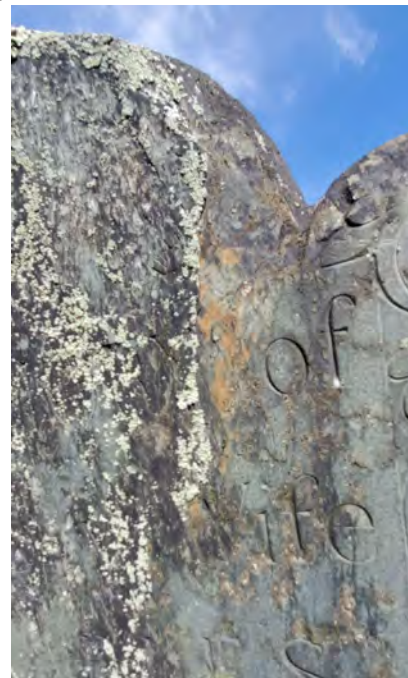
Left: marker 72 in 2020 prior to restoration. Right: a detail of the condition at the top right of the marker confirming the needlessly large unsightly patch that was implemented.

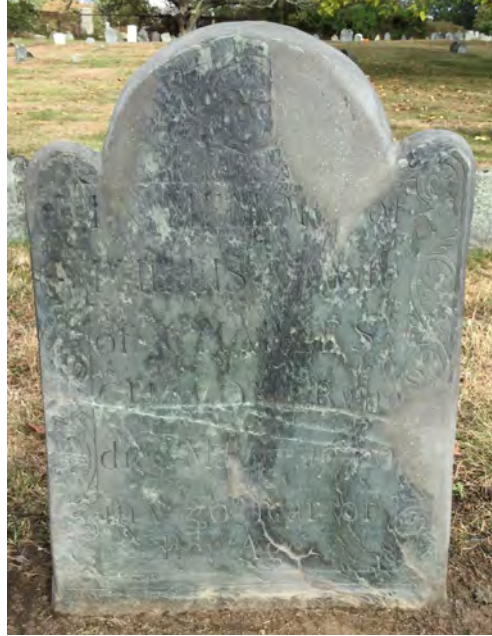
Marker 72 in 2020 shortly after its restoration: the patching mortar was visually jarring then as well. The color then somewhat matched the stone but the inclusions or aggregate of the patching mortar were already unsatisfactory.

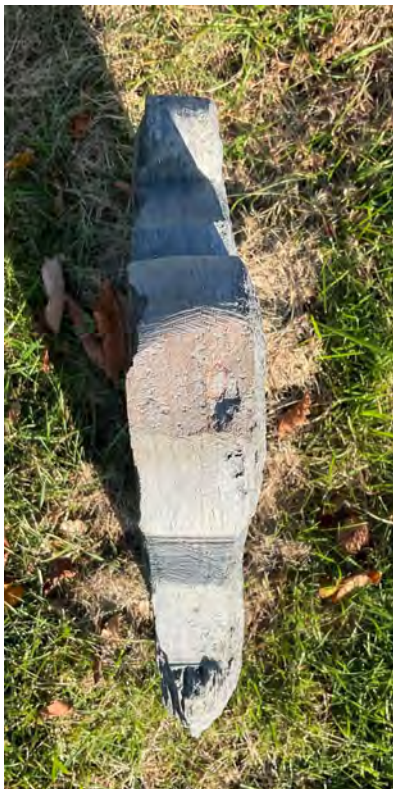
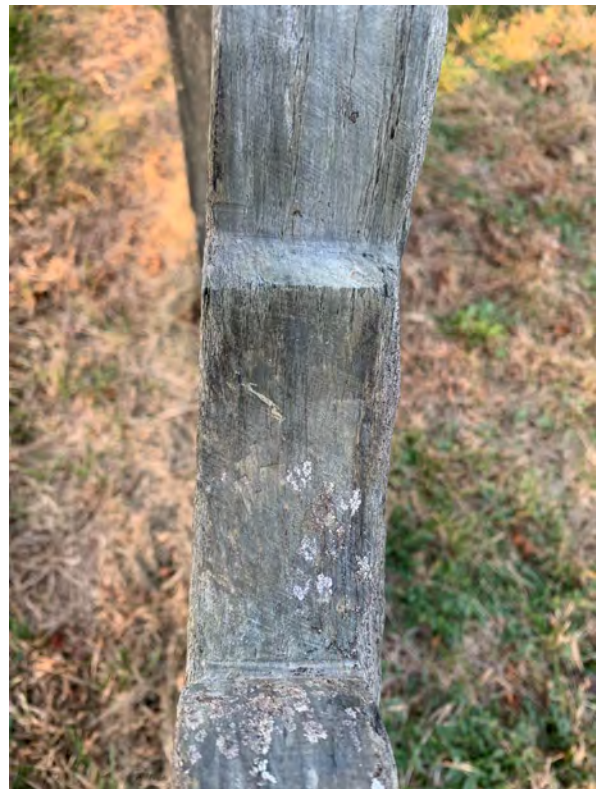
Evidence of another repair campaign on two different markers. This repair campaign does not have any associated documentation so the dates of execution are unknown. The delaminated tops of select markers have been tooled to relatively sound stone. It is an aggressive intervention but appears to have arrested the delamination.

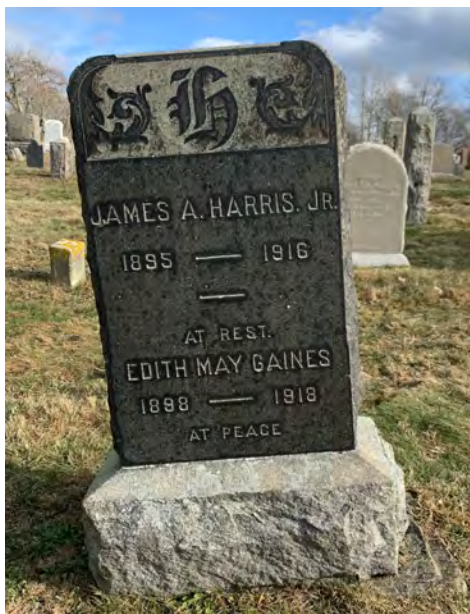
Marker 269 is a granite with Soiling of a Severity of 1.

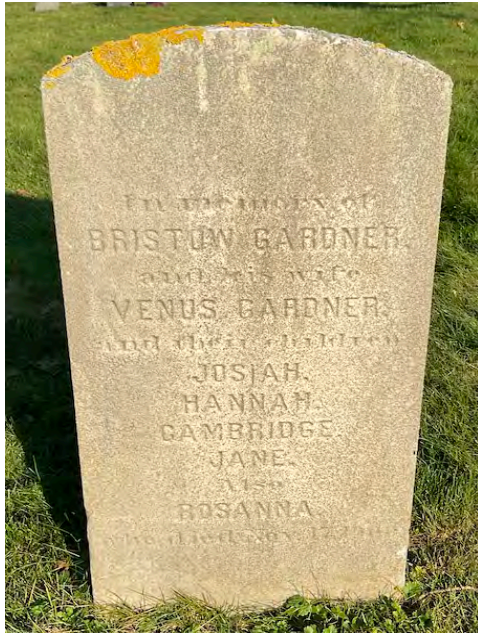
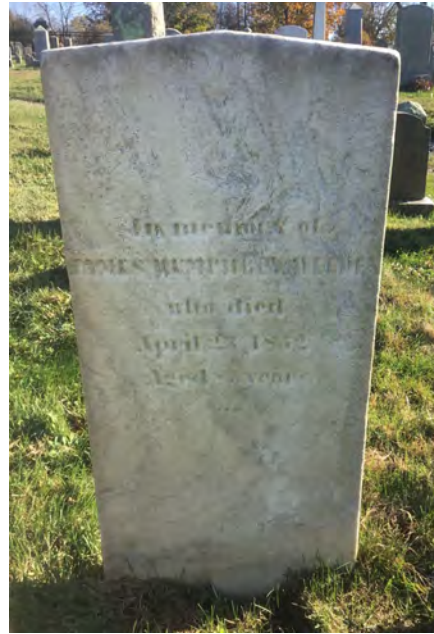
Markers 317 and 355 are typical examples of atmospheric soiling.

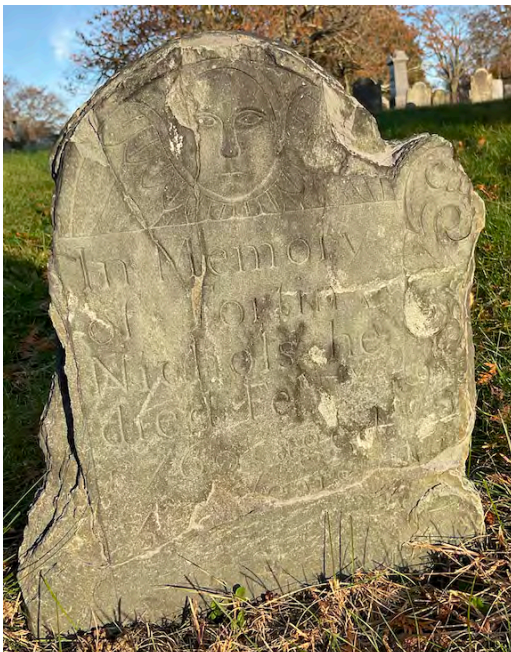
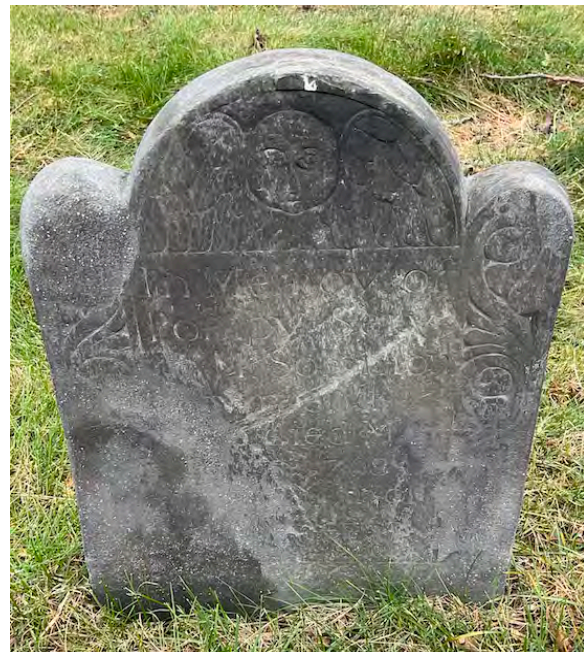
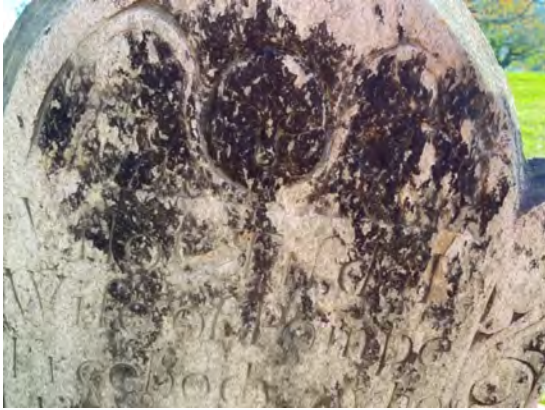
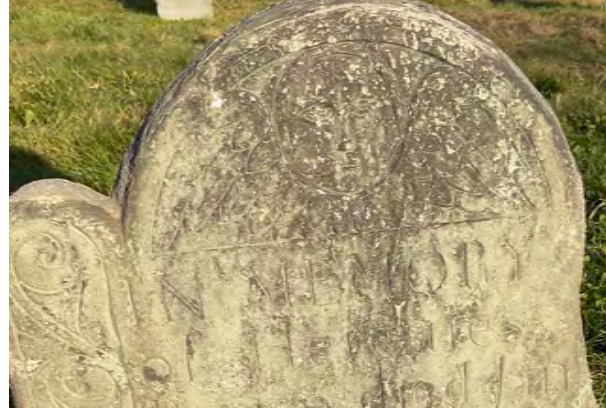
Of the slates, 105 had marked soiling. A recurring black soiling pattern localized in the tympanum was observed on some slates concentrated around the winged faces. Evidence is noted in the "Notes" section of forms since it was not an expected condition, and became clear only after days of surveying. Forty-five markers exhibited this. As these blackened surfaces appeared and felt waxy to the touch, it's possible that a previous wax coating or other soapy surface treatment had been applied, as part of a historic maintenance or cleaning routine. A treated surface may have collected and held particulate, or alternatively a black pigment may have been applied within the waxy binding medium as decoration. Solvent tests and extractions from microscopic sampling of the surface coupled with analyses by Fourier Transform Infrared Spectroscopy (FTIR) and/or Gas Chromatography-Mass Spectrometry (GC-MS) could reveal more information about the nature of this blackened surface.

Markers 333 (top left), 321 (top right), 201 (lower left) and 422 (lower right) show different manifestations of the black soiling found concentrated in the tympanums of 45 markers.

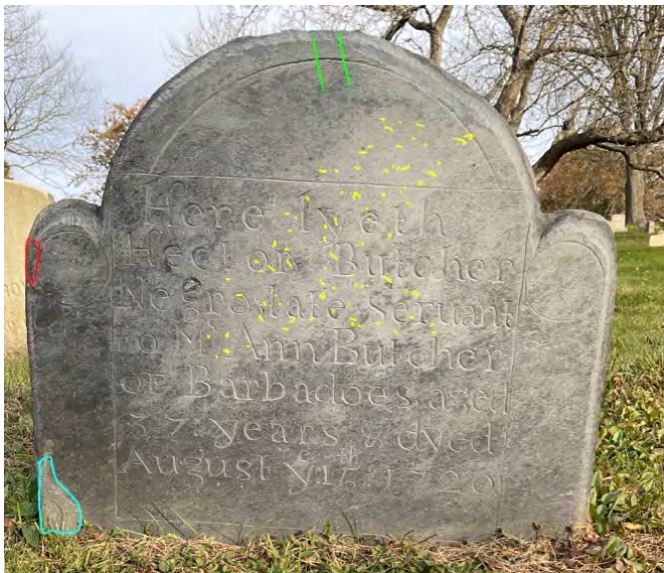
Marker 117 annotated for conditions.
