**GOD'S LITTLE ACRE  
NEWPORT COMMON BURIAL GROUND  
NEWPORT, RHODE ISLAND  
TREATMENT REPORTS FALL 2025-SUMMER 2026**

**CONSERVATION TREATMENT REPORTS  
FALL 2025-SUMMER 2026  
WORK SEASONS**

Francis Miller, Conservator, PA AIC  
Conserve ART LLC

August 17, 2026

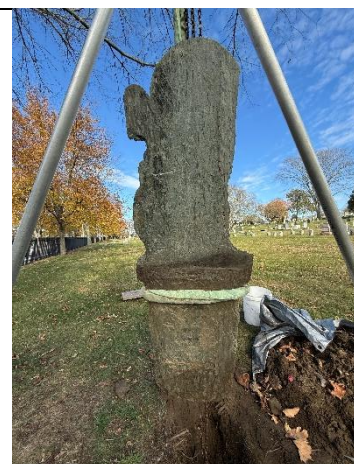
GLA 031 8. DT. Removal with tripod detail.

■ **Removal for Treatment:** The marker was unearthed and the area searched for fragments. The stone is heavy and required lifting by tripod. No substantial fragments were found. The marker was placed in a wood crate and brought to the studio in Hamden, CT.

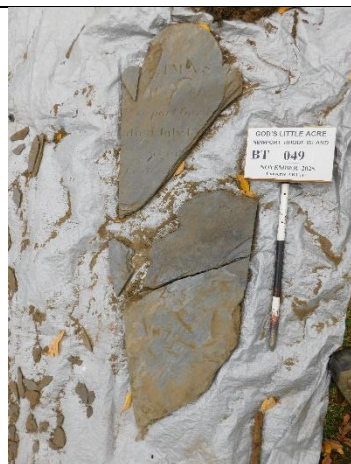
GLA 049 2. BT. Front overview of unearthed major sections.

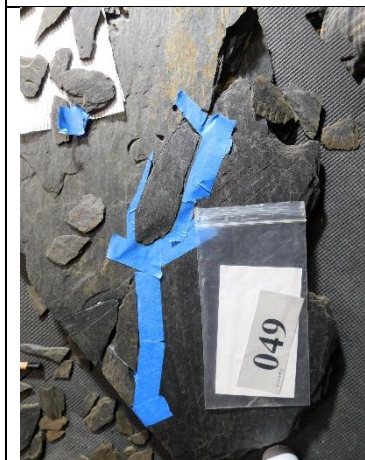
GLA 049 17. DT. Fitting and adhering fragments on lower face.

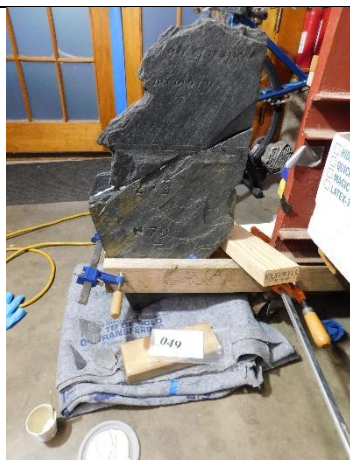
GLA 049 18. DT. Fitting and adhering major sections with Akemi Akepox 2030.

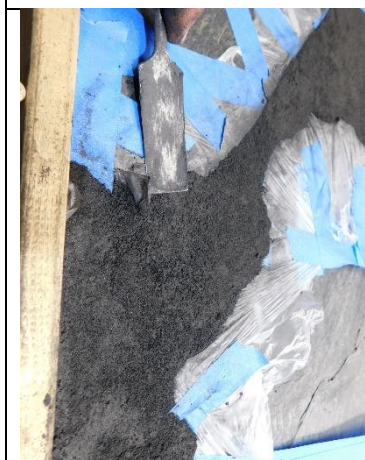
GLA 049 21. DT. Tooling Edison Coatings Systems 45 with Marine Latex in losses.

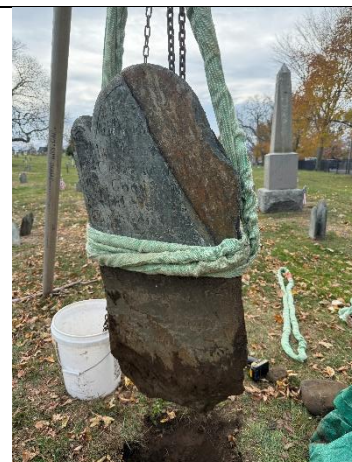
GLA 055 8. DT. Removal with tripod detail.

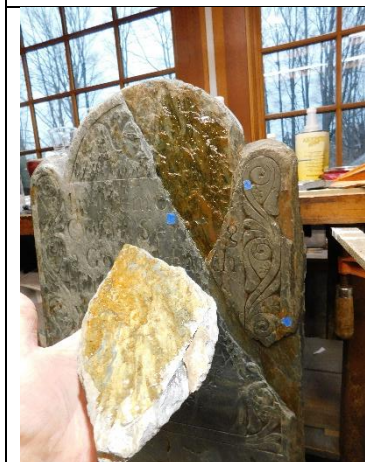
GLA 055 17. DT. Adhering middle face section with Akepox 2000.

■ **Repairs:** Front face fragments were fit and adhered with Akepox 2000, a thinner epoxy as compared to 2030.

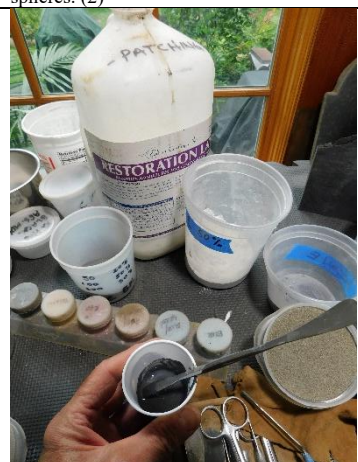
CBG MC-FC 19. DT. Mixing Edison Coatings Systems 45 and slate dusts.

■ **Fills:** Small fills were done with 20-60% B-72 bulked with slate dusts and Cenospheres. Larger crack openings were filled with Edison Coatings Systems 45 with the addition of 50% slate aggregates. The fill materials were tinted with Bayferrox pigments to blend in color with the surrounding stone.
