God's Little Acre Condition Assessment Final Report

March 2022

For:
Giles Eyre
GLAPP Foundation

By:
Amanda Trienens
Cultural Heritage Conservation LLC

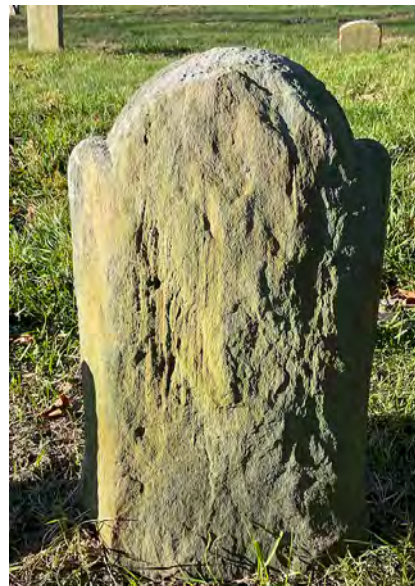
Marker 289 depicts the typical green algae.

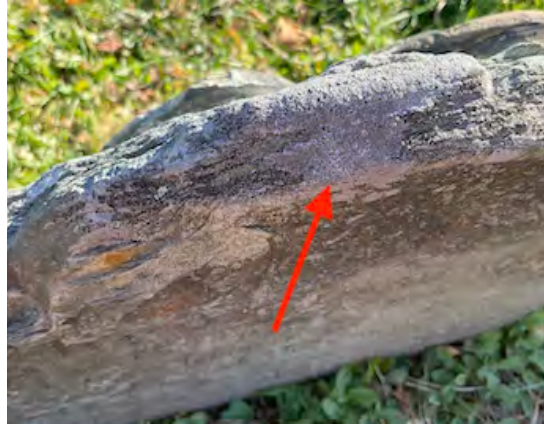
Marker 201 exhibits crustose lichens, a hard layer that looks like cement as a result of integration of minerals from the stone into the lichen structure.

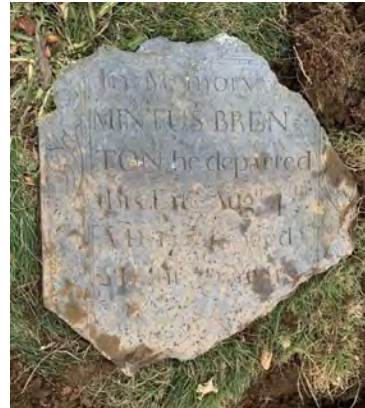
Marker 409 after being unearthed for surveying illustrates the piece is only a fragment of the original marker. Discussion of fragments is provided later in this report.

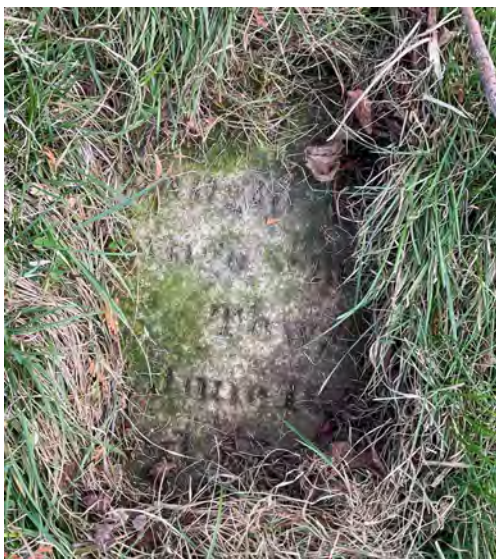
Marker 326 could be a fragment from a larger marker that has gotten buried over time or the only portion visible of a much larger fallen and mostly buried marker. It could also be a flat flush tablet style of marker that has sunk into the ground and grass has grown over it.

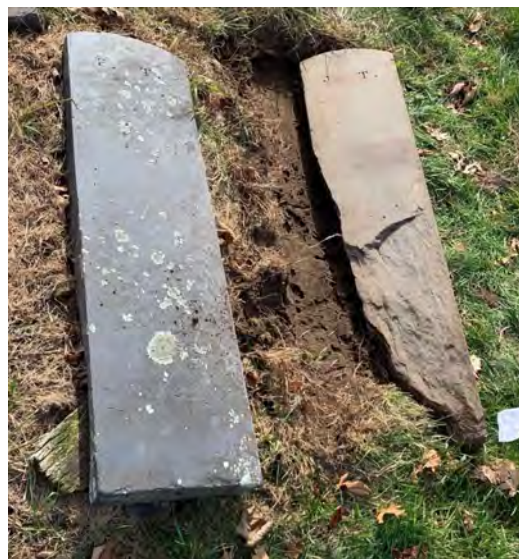
Marker Unlisted (185) on the right is a footstone that was mostly buried but once unearthed was discovered to have enough stone (despite some loss) to be reset. The stone can be set slightly deeper than it may have originally been for more support, especially since it is a footstone and the inscription will not be covered. On the left is Marker Unlisted (185x) that is fallen or unearthed but can also be reset.

→ Guidance on treatment: The area where the marker is to be set should be dug approximately 4" deep, filled with 1" to 1.5" diameter gravel and tamped down to provide drainage. The marker should be set in place slightly nestled in the gravel and ensured that it is level and stable. The gravel can be covered with a mixture of smaller gravel and dirt or the existing sod, but it is recommended there is a berth of one foot around the perimeter of the marker at a depth of 4" of gravel to protect the marker from landscaping equipment and allow for drainage.

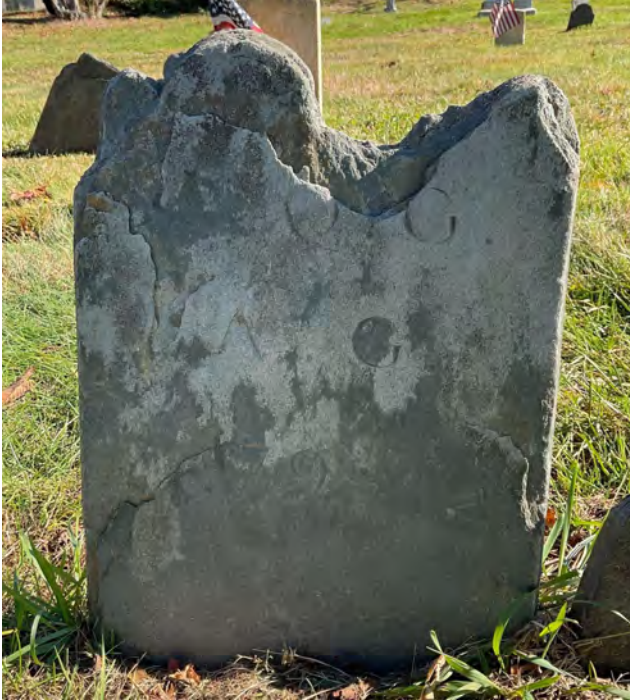
Example of Priority 2 Delamination that consist of treatable voids and gaps due to delamination/ The little legible inscription that remains is under threat of loss.

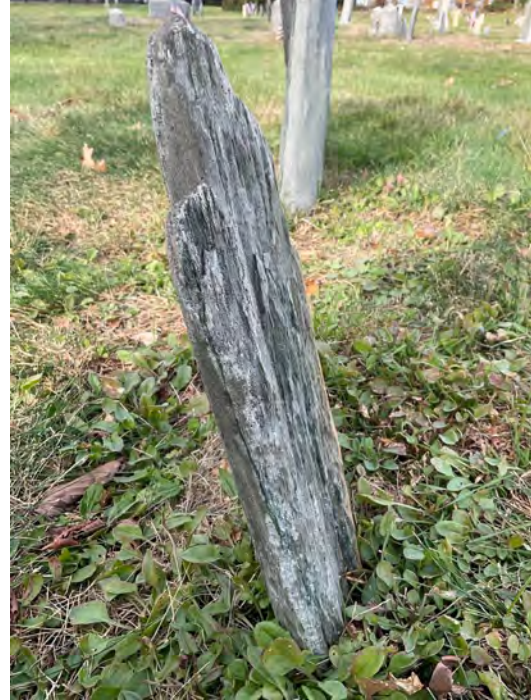
An example of Priority 3 Delamination – the grave marker has only a couple small areas that are treatable; it also has little potential for loss of material of its front face which no longer contains an inscription.

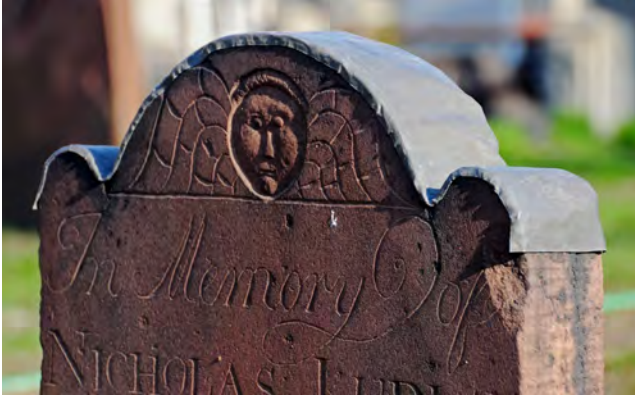
This lead cap is somewhat better in its execution (online image) than the one at GLA.

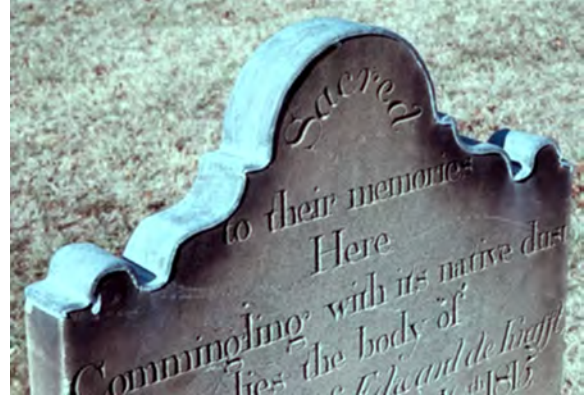
This is a far superior cap but it is fabricated out of copper which is not recommended due to salvage value (online image).

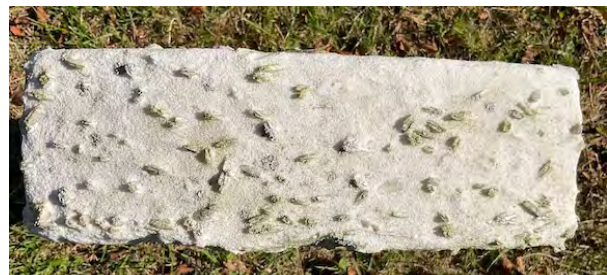
Marker 148 exhibits Disaggregation Severity 4, with fine crystals lost, larger crystals are exposed on the surface. That so much fine particulate has been lost but the surface is not sugaring at present may indicate a consolidation treatment was applied in the past.

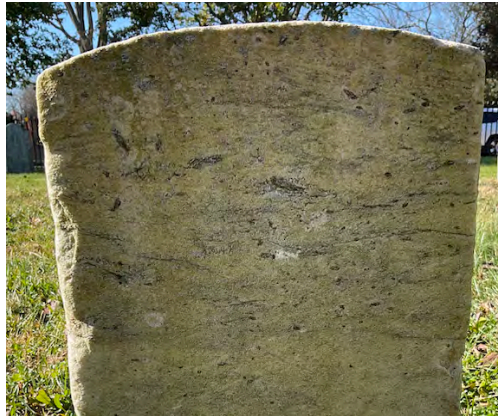
Marker 149 is an example of a marble with mild Disaggregation of a Severity of 4.

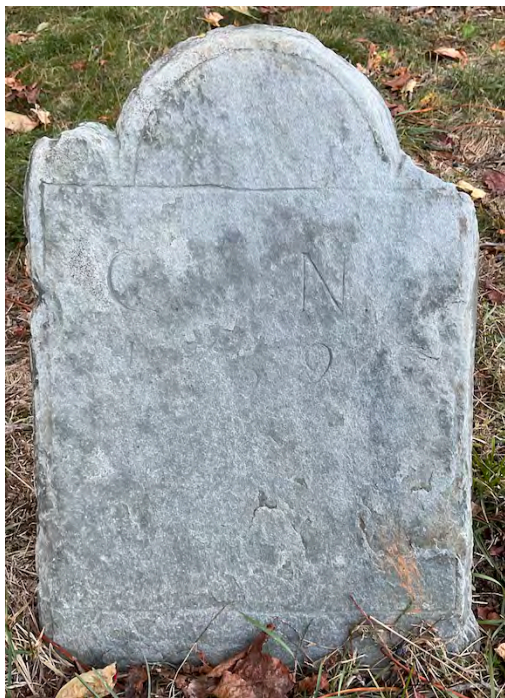
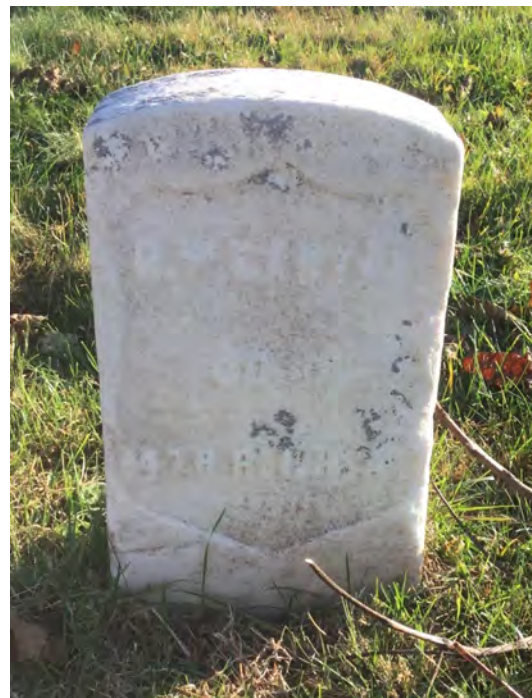
Marker 193_fs (left) and Marker 268 (right) are examples of Erosion Severity I.

→ Guidance on treatment: No treatment can arrest or remedy erosion, except for the sheltering or removal of grave markers from the outdoor environment. To mitigate the risks of loss associated with erosion, three-dimensional documentation of grave marker inscriptions should be considered. Laser scanning and 3-d photography of relief surfaces is becoming more accessible with tools such as iPhone's LIDAR. Investment in documentation can produce the greatest long-term return on investment for a collection of outdoor monuments that will inevitably continue to erode with time. A digital record of individual markers and the landscape as a whole would provide valuable assets for future research, educational and engagement initiatives.

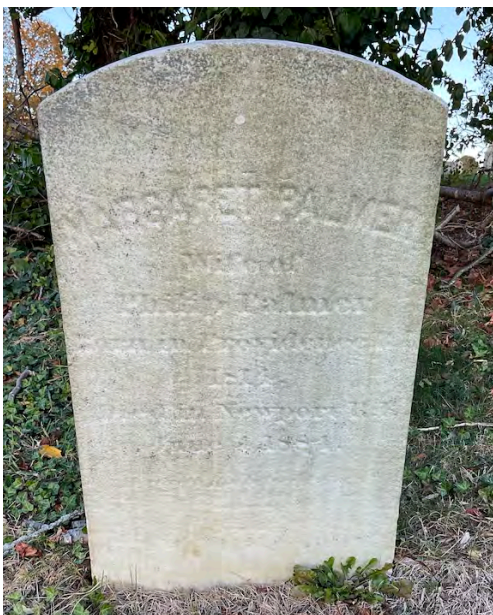
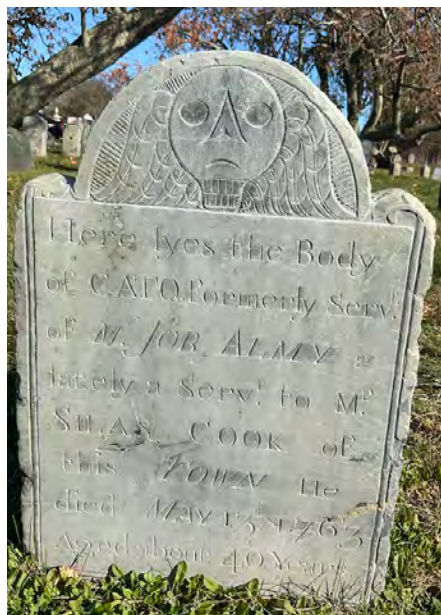
Exceptions exist however, such as one marker from the 18th century (Marker 418) whose carving details are still so crisp that one can see the scribed guidelines for the lettering. Two other examples at the Common Burial Ground by the same carver exhibit the same material and manufacturing quality.

Left: Marker 229 shows the typical appearance of how erosion blurs details of carving, Severity 2. Right: Marker 418 dated 1763 retains crisp details of the lettering guidelines.

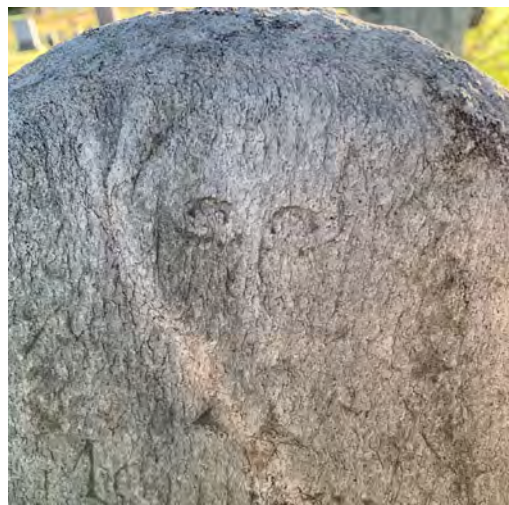
Another example of flaking but it is less densely stacked so presents more potential for loss; also designated Severity I

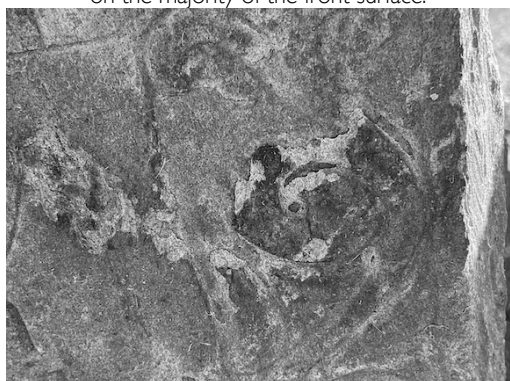
Marker 201 is an example of flaking that is treatable.

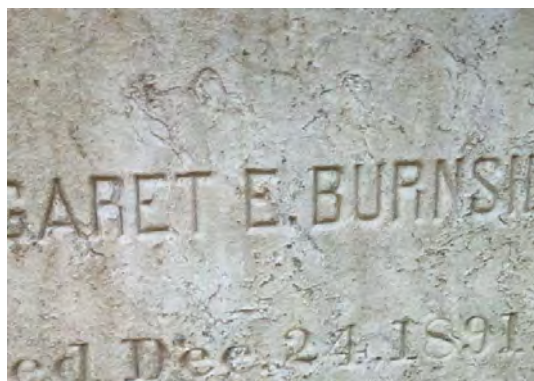
Example of flaking on marble.

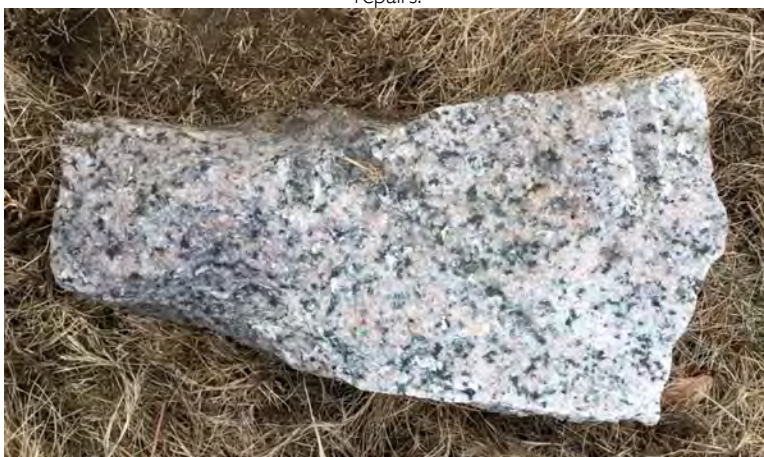
Example of a fragment that is believed to be a part of an old post due to tooling mark, but not a marker.

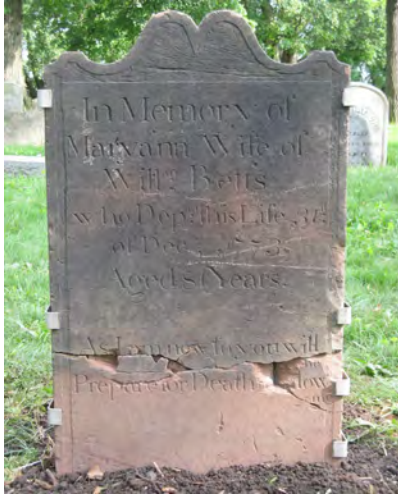
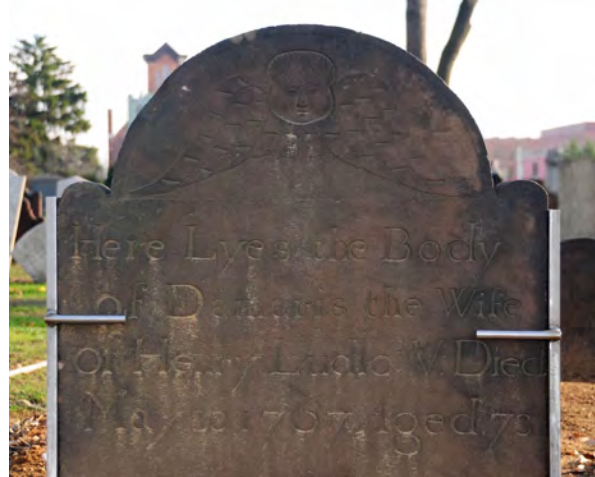
The above two images from CTA Architects website are examples of mounted markers. These are brownstone markers, which depending on the variety of stone is also plagued with delamination. Though the markers were not fragments it provides an idea of mounting options.

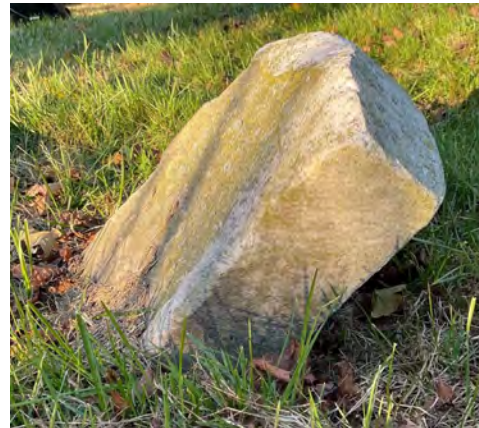
The marble though thicker warrants resetting due to its angle.

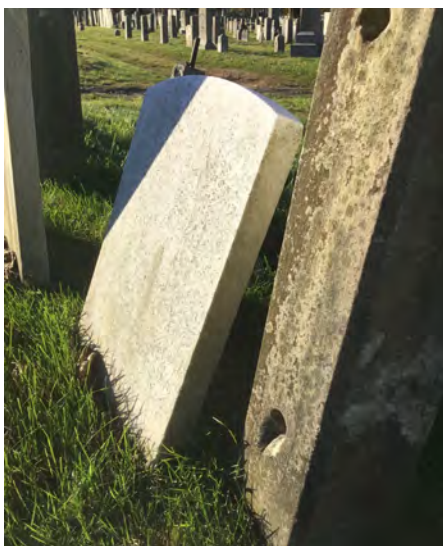
The marble marker being thin, at an acute angle to the ground and leaning towards a post warrants its resetting.

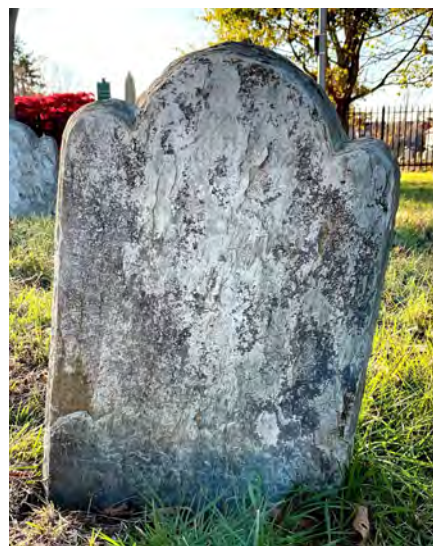
Unlisted (075) is an example of a marker that is leaning to the side at a slight angle so does not need to be reset.

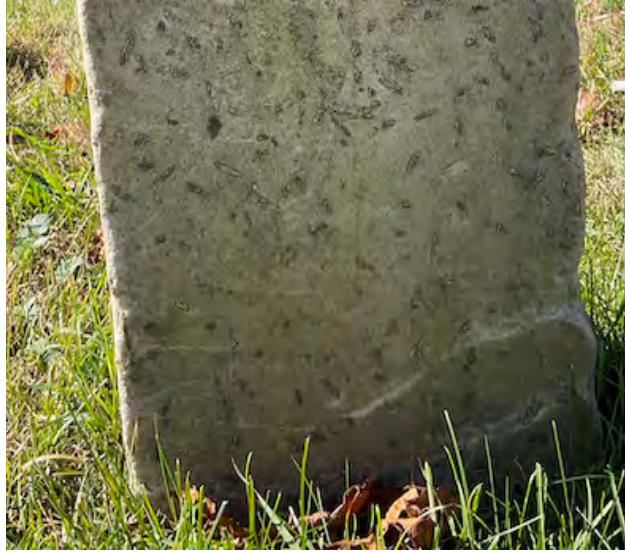
Marker 150 has multiple losses and fresh scrapes due to mechanical abrasion presumably from lawn equipment.

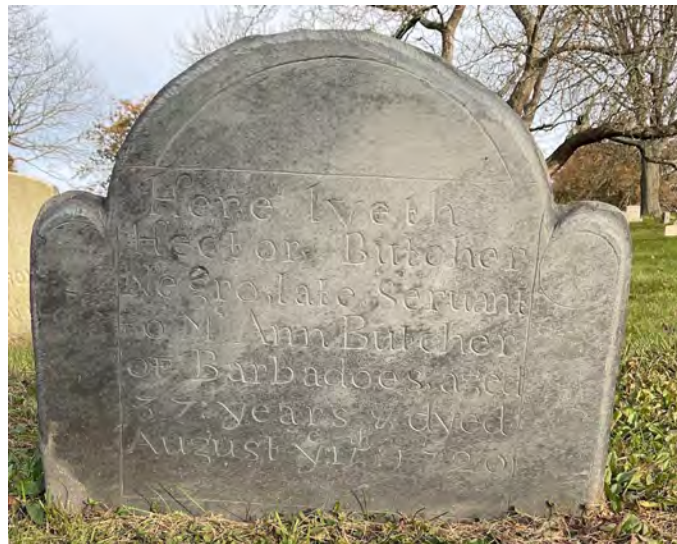
Marker 117 dated 1720.

The survey revealed a site and collection of markers that have changed over time, with tree roots dislodging markers, footstones out of position, markers leaning at all angles, some disappeared buried into the ground, fragments of stones leaning against others, and repairs that have been poorly executed. More than two-thirds of all the stones (446/641) had losses, including over eighty percent of slates (309/370). The majority of twentieth century marble and granite stone markers are in stable condition, while the historic slates, vary across a spectrum of stability, associated with their mineral composition. Conditions of markers were not related to their location on the site or directly correlated with their age, for instance Marker 117, one of the oldest markers at GLA.

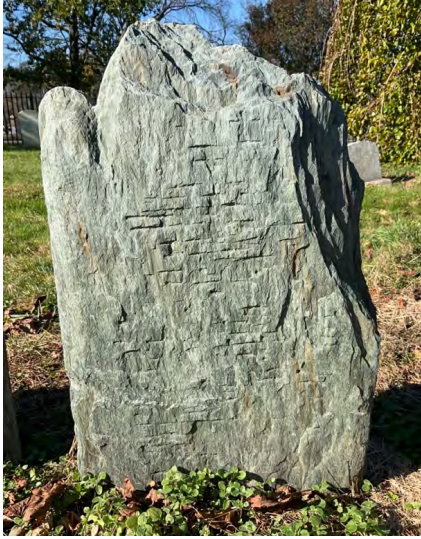
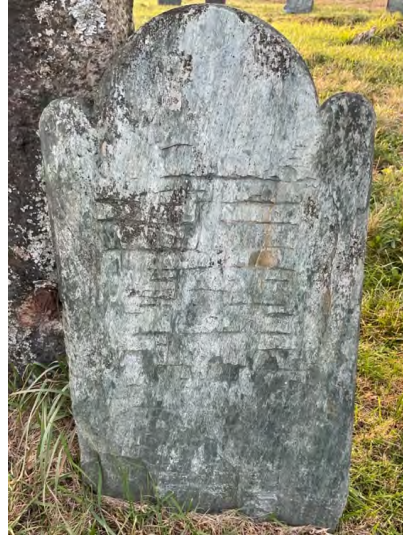
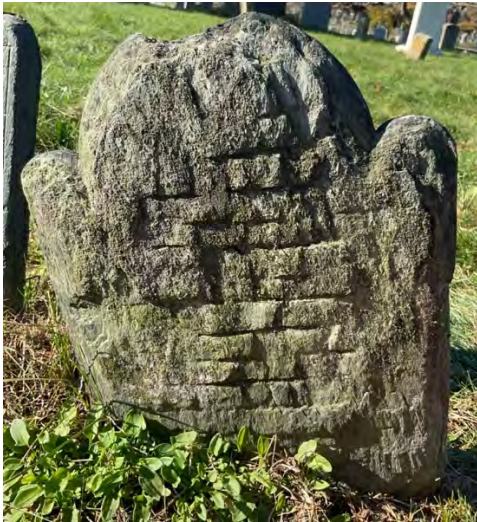
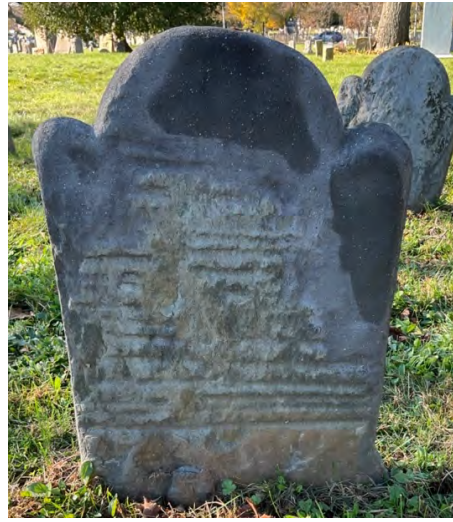
A sampling of the markers with horizontal tooling on their backs, likely from manufacture.

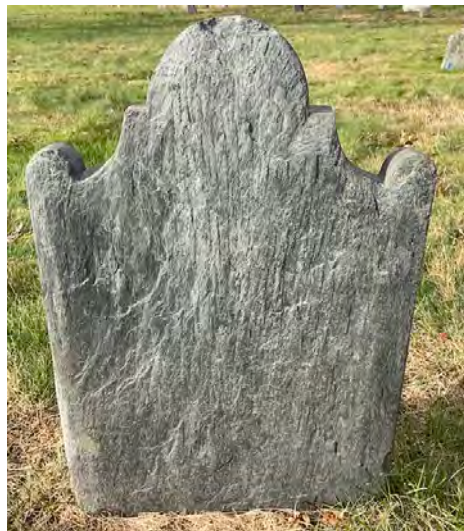
Marker 343 has a vertical pattern of tooling on its back.
