**GOD'S LITTLE ACRE  
NEWPORT COMMON BURIAL GROUND  
NEWPORT, RHODE ISLAND  
TREATMENT REPORTS FALL 2025-SUMMER 2026**

**CONSERVATION TREATMENT REPORTS  
FALL 2025-SUMMER 2026  
WORK SEASONS**

Francis Miller, Conservator, PA AIC  
Conserve ART LLC

August 17, 2026

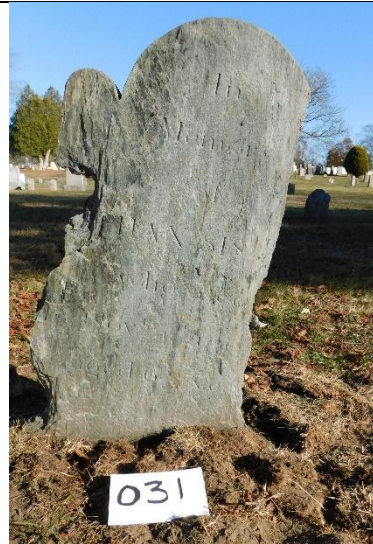
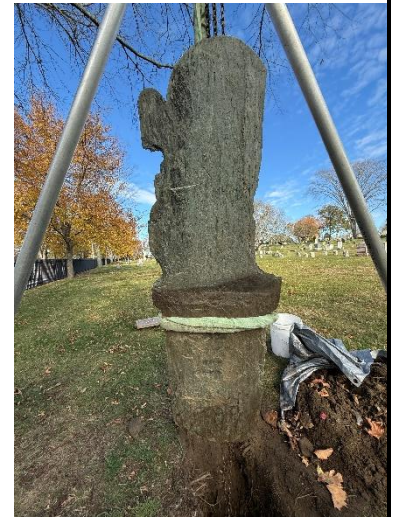
Front overview before treatment

■ **Growth/Soiling:** The surface has only minor growths or possible attached dead growths. Small plates have root growth in the cracks below grade. Lawn clippings have adhered to the visible surfaces. Black, possible carbon deposits on proper right side.

■ **Delamination:** The front and back have numerous micro delaminations. The micro separation has caused loss to sculptural detail and speckled coloration by exposing "fresh" stone in contrast to an aged surface patina approximately 269 years old. Macro separations can be clearly seen on the sides and top of the maker. Macro delamination is causing more severe cracking and loss.

■ **Cracks:** Cracks are formed along the delamination. Larger cracks are visible on the top, and sides, particularly at impact points and breaks.

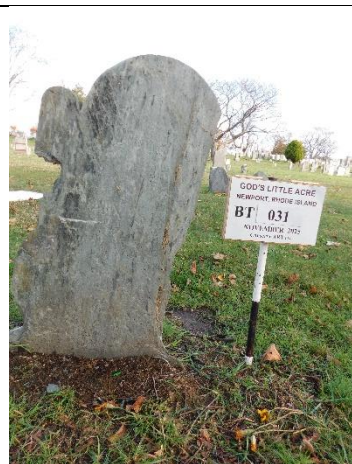
GLA 031 2. BT. Front overview.

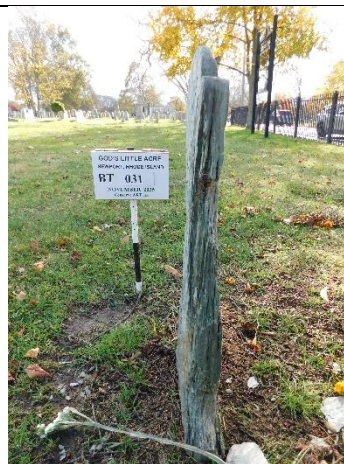
GLA 031 3. BT. PL overview.

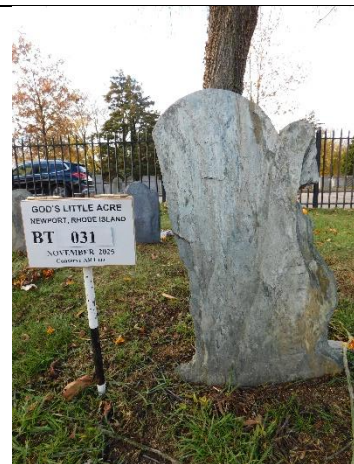
GLA 031 4. BT. Back overview.

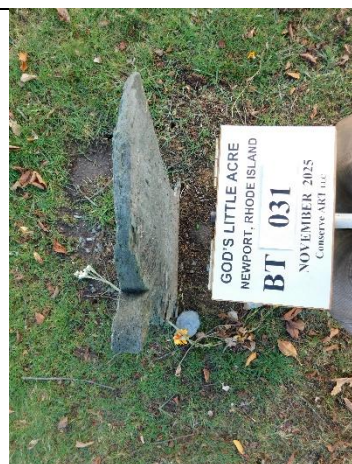
GLA 031 6. BT. Top overview.

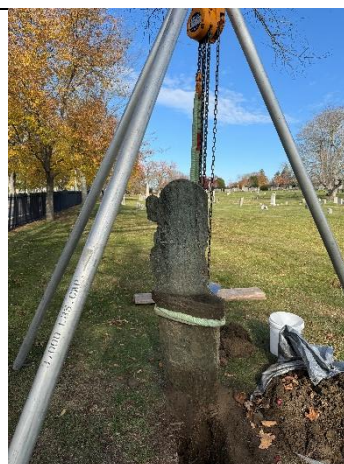
GLA 031 7. DT. Removal with tripod.

■ **Removal for Treatment:** The marker was unearthed and the area searched for fragments. The stone is heavy and required lifting by tripod. No substantial fragments were found. The marker was placed in a wood crate and brought to the studio in Hamden, CT.

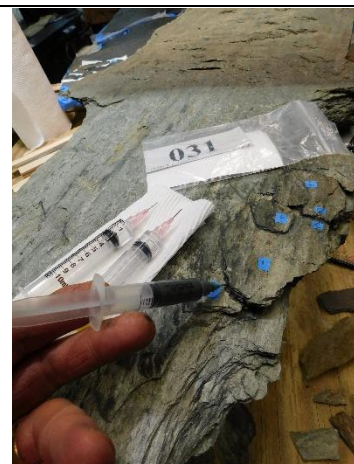
GLA 031 16. DT. Capping adhered fragments with B-72 bulked with slate dusts.

■ **Fills:** Small fills were done with 20-60% B-72 bulked with slate dusts and Cenospheres. Crack openings and caps were filled with Edison Coatings Systems 45 with the addition of 50% slate aggregates. The fill materials were tinted with Bayferrox pigments to blend in color with the surrounding stone.

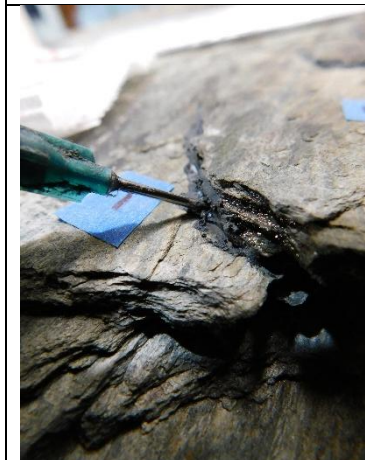
GLA 031 17. DT. Capping adhered fragments with B-72 bulked with slate dusts.

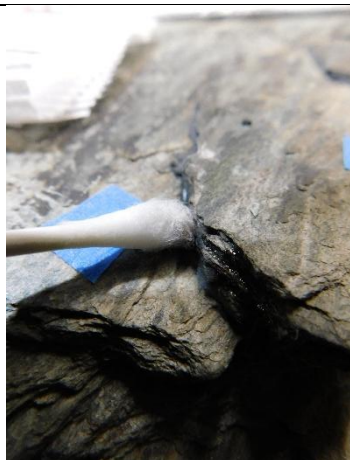
GLA 031 18. DT. Cleaning caps with acetone dampened cotton swabs.

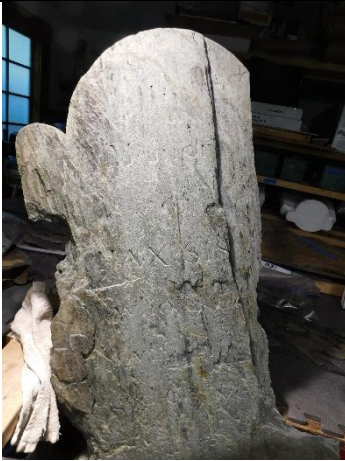
GLA 031 25. DT. Detail of front carving after treatment in studio.

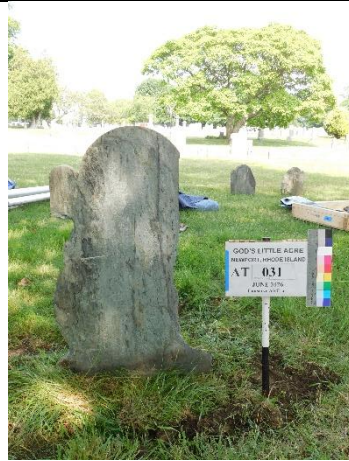
GLA 031 26. AT. Front overview.

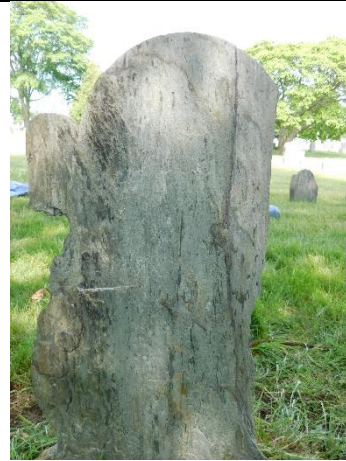
GLA 031 27. AT. Front overview detail.

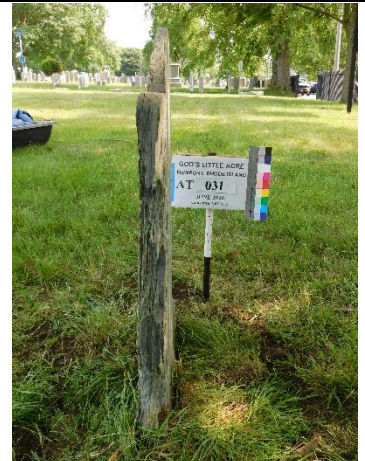
GLA 031 28. AT. PL overview.

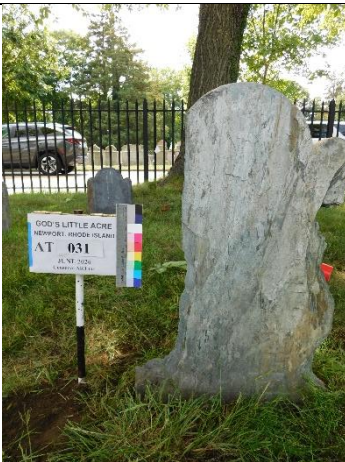
GLA 031 29. AT. Back overview.

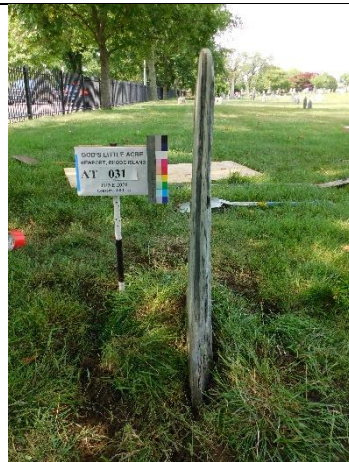
GLA 031 30. AT. PR overview.

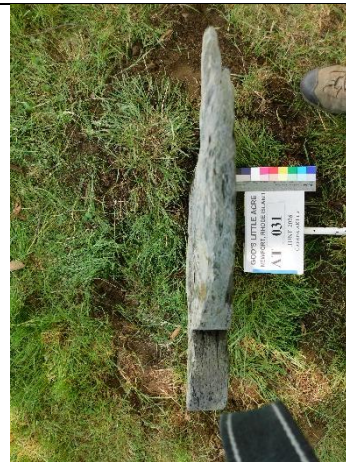
GLA 031 31. AT. Top overview.

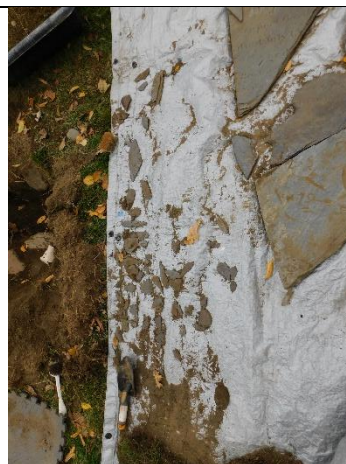
GLA 049 3. BT. View of smaller fragments.

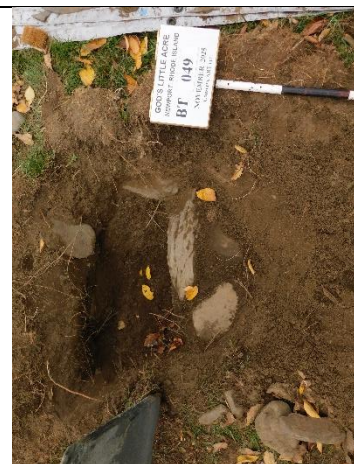
GLA 049 4. BT. View of stones buried below marker.

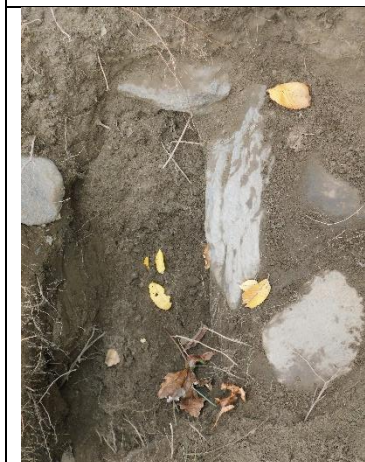
GLA 049 5. BT. Detail of stones buried below marker.

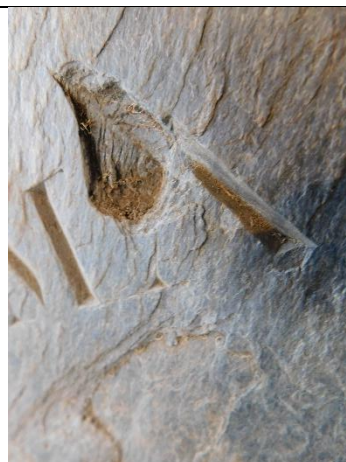
GLA 049 7. DT. Detail of roots in face carving separations.

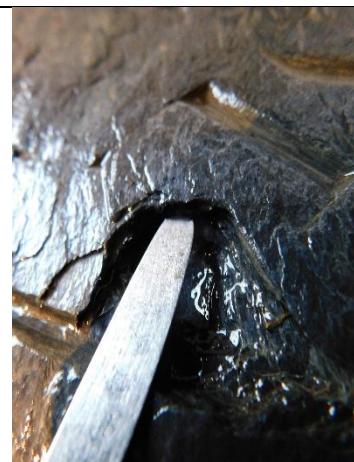
GLA 049 8. DT. Removal of roots from face carving.

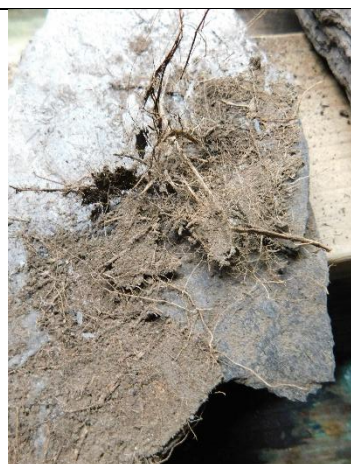
GLA 049 10. DT. Detail of roots and debris in separation.

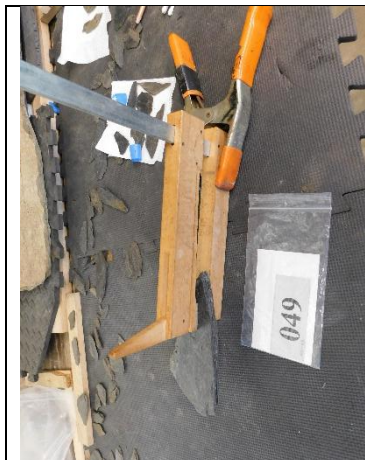
GLA 049 13. DT. Fitting and adhering fragments.

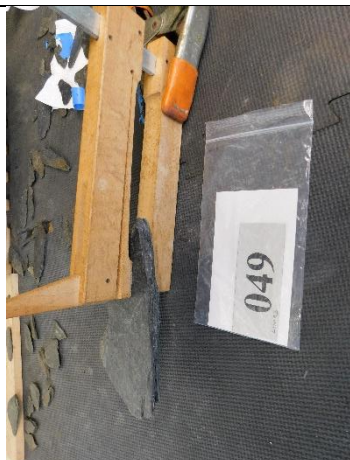
GLA 049 14. DT. Fitting and adhering fragments.

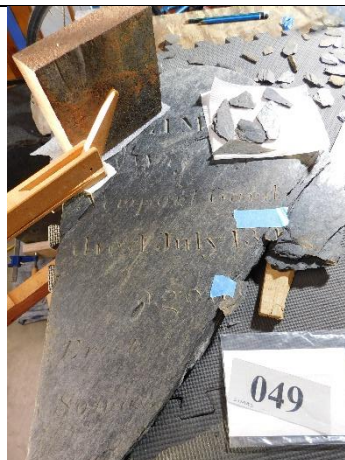
GLA 049 15. DT. Fitting and adhering fragments on face with weights.

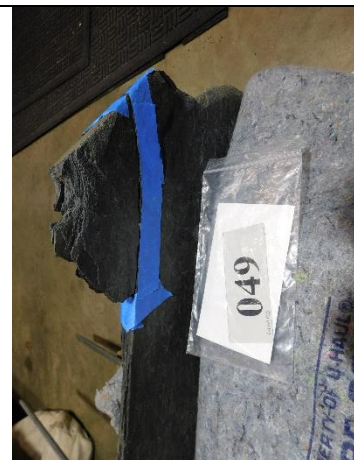
GLA 049 16. DT. Fitting and adhering fragments on proper left side.

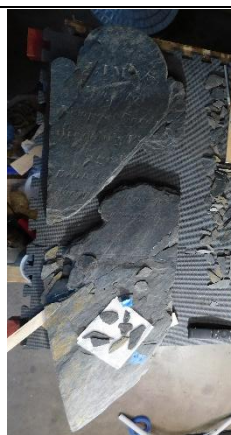
GLA 049 19. DT. Overview of major sections and fragments adhered and final check to fit smaller fragments.

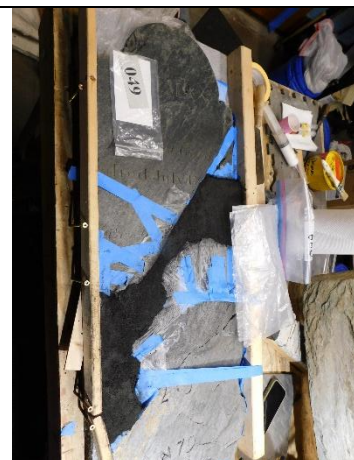
GLA 049 20. DT. Casting and tooling Edison Coatings Systems 45 with Marine Latex in losses.

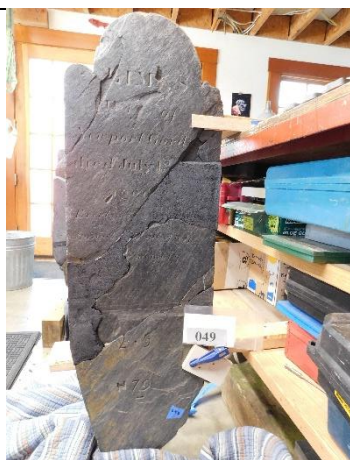
GLA 049 22. DT. Adhering casts with Akemi Akepox 2030 with Coloring Paste for tinting.

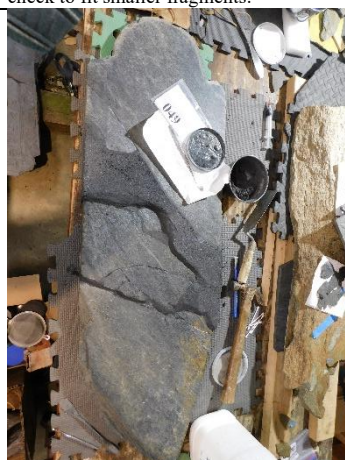
GLA 049 23. DT. Tooling Edison Coatings Systems 45 with slate dusts in losses and break-lines.

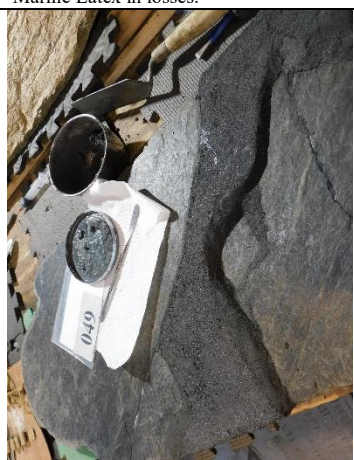
GLA 049 24. DT. Tooling Edison Coatings Systems 45 with slate dusts in losses and break-lines.

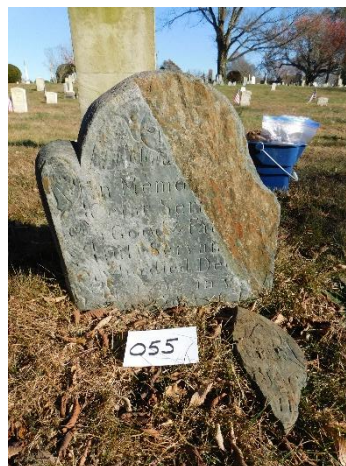
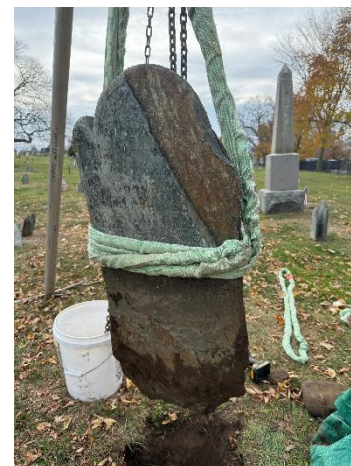
Front overview before treatment

The marker is a light blue to grey slaty stone with iron rich minerals in the cleavage planes. The stone is not well metamorphosed or formed into a durable slate. The cleavage planes are slightly folded and dip down toward the back and proper right with shallow delaminated, platelet separation.

■ **Growth/Soiling:** The surface has only minor growths or possible attached dead growths. Small plants have root growth in the cracks below grade. Lawn clippings have adhered to the visible surfaces.

■ **Cracks:** Minor cracks at the delaminations and larger cleavage cracks running vertically to the back of the stone. Larger delamination cracks are found on the lower proper right side and on the proper left edge.

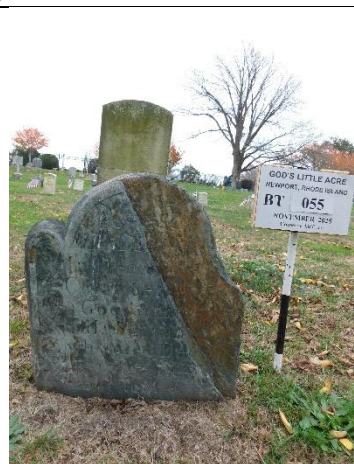
GLA 055 2. BT. Front overview.

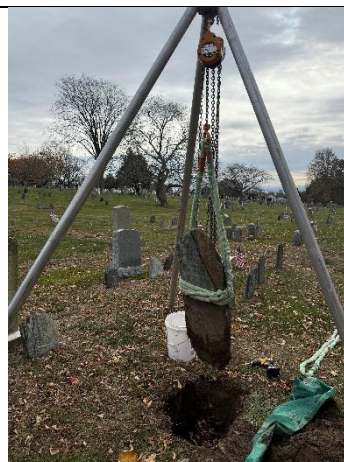
GLA 055 7. DT. Removal with tripod.

■ **Removal for Treatment:** The marker was unearthed and the area searched for fragments. Two large fragments with face carving were found, bagged and labeled with the marker number. The bottom portion of the marker stone is thick and heavy, requiring a tripod for removal. The marker was placed in a wood crate and brought to the studio in Hamden, CT.

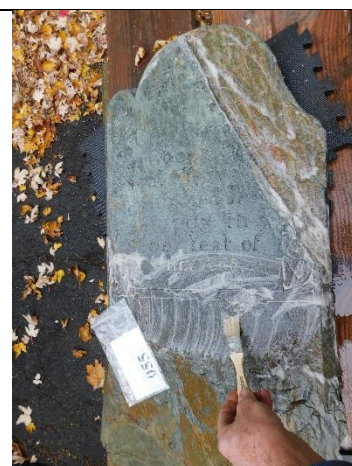
GLA 055 12. DT. General cleaning with Orvus solution.

■ **General Soiling Removal:** The surfaces were rinsed with filtered water and cracks flushed with pressurized water and syringe to remove debris, dirt and roots. The stone was cleaned with a solution of Orvus, anionic detergent, with gentle agitation using natural fiber brushes. Small grass fibers were very difficult to remove. Buried face fragments were soaked in an Orvus solution for 1 hour and lightly brushed. The fragments were copiously rinsed and allowed to soak in water baths for 2 hours. Due to the high concentration of iron compounds in the stone, the buried fragments were not cleaned with acidic cleaners and remained lightly soiled.

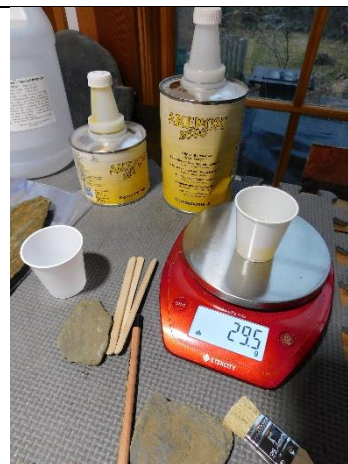
GLA 055 15. DT. Weighing components of Akemi Akepox 2000.

■ **Repairs:** Front face fragments were fit and adhered with Akepox 2000, a thinner epoxy as compared to 2030.

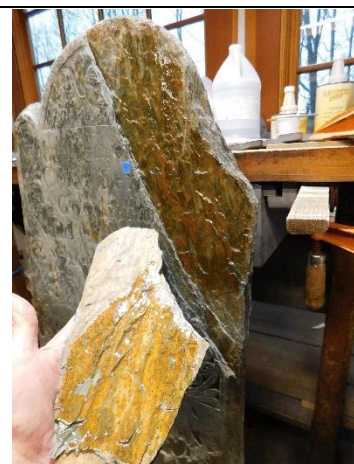
GLA 055 16. DT. Adhering proper left shoulder fragment with Akepox 2000.

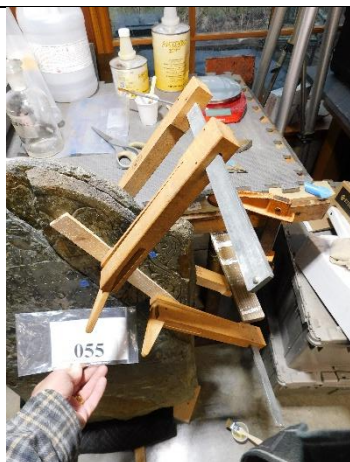
GLA 055 18. DT. Fragments clamped for 24 hour epoxy cure.

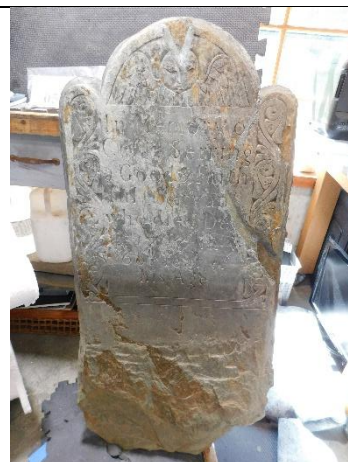
GLA 055 19. DT. Overview of marker after Edison Coatings Systems 45 fills.

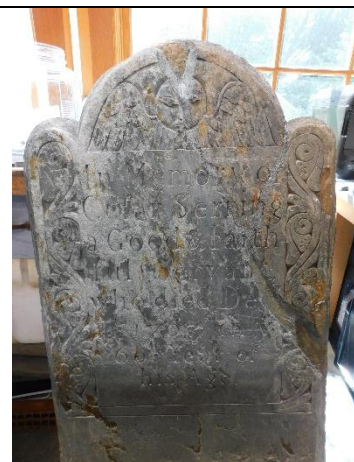
GLA 055 20. DT. Overview of front carving after Edison Coatings Systems 45 fills.

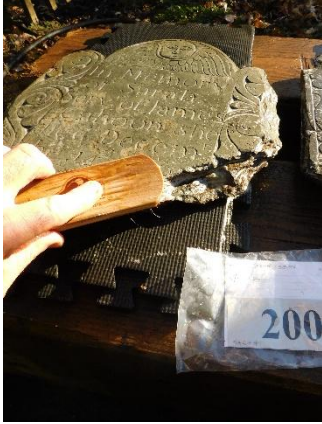
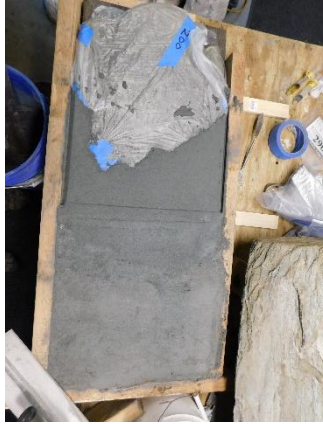
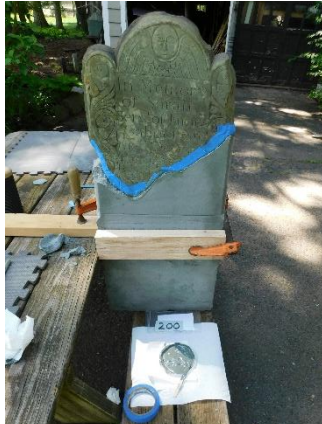
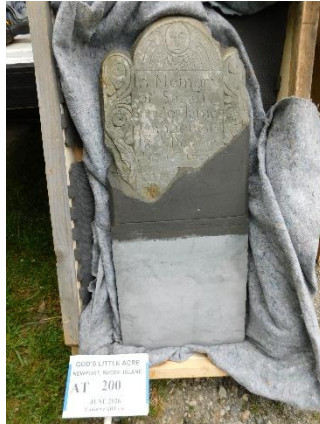
The marker is a blue-grey slatey stone with minor areas with iron compounds in cleavage. Cleavage runs at a slight angle upward toward the back of the stone. The marker has a bow with the top and bottom lifting when set flat.

■ **Cracks:** There is a large cleavage crack in the top tympanum and proper right side, running at a diagonal, as well as some smaller separations.

■ **Hazardous Alignment:** The marker had fallen and has no lower support.

■ **Removal for Treatment:** The marker was unearthed and the area searched for fragments and those found, bagged and labeled with the marker number. The marker was placed in a wood crate and brought to the studio in Hamden, CT.

■ **General Soiling Removal:** The surfaces were rinsed with filtered water and cracks flushed with pressurized water and syringe to remove debris, dirt and roots. The stone was cleaned with a solution of Orvus, anionic detergent, with gentle agitation using natural fiber brushes. Small grass fibers were very difficult to remove.

■ **Crack Injection:** The top cleavage crack was cleaned as possible as well as cracks in the break-lines. The stone dried for 2-3 weeks prior to injections. Injections were made with B-72 with the addition of slate dusts and ceramic microspheres for larger openings.

■ **Loss Replacement:** The lower section was cast with Edison Coatings Systems 45 using Marine Grade Latex and tinted with Bayferrox pigments. The thickness was oversized with the back extending further for additional strength of the composite material. The cast lighted considerably after curing and requiring the visible portion to be stained with a darker slurry of the same casting material. The cast was joined with Akemi Akepox 2030 Epoxy tinted with Akemi Coloring Paste.

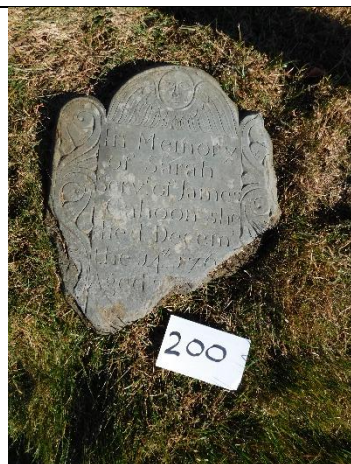
GLA 182. 2. BT Front view.

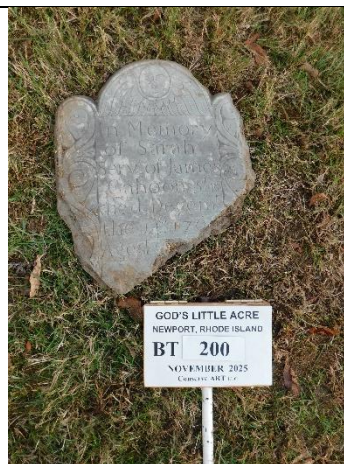
GLA 200 3. BT. Front overview.

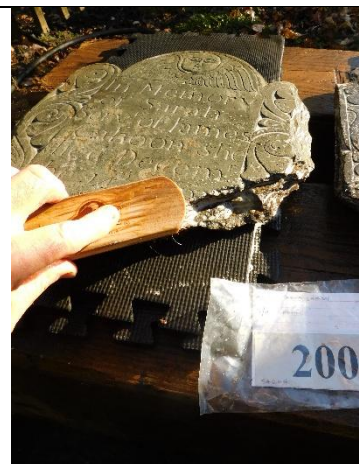
GLA 200 4. DT. General cleaning with Orvus and water.

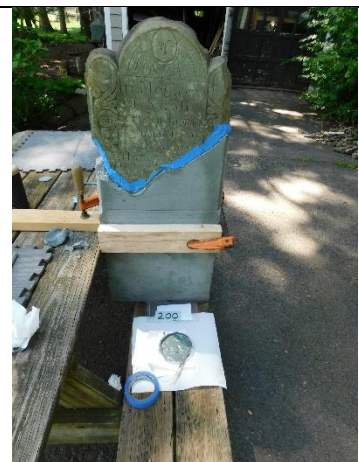
GLA 200 8. DT. Joining cast and marker with Akemi Akepo 2030.

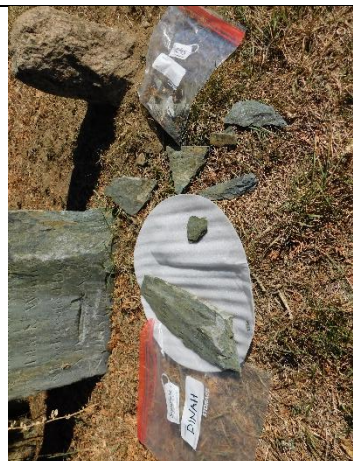
GLA 275 2. BT. Gathering fragments.

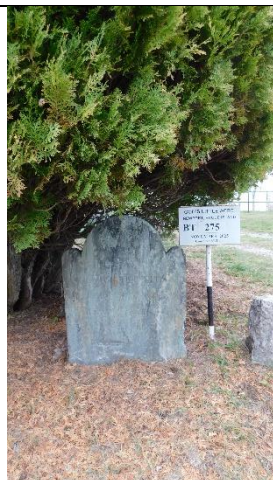
GLA 275 3. BT. Front overview.

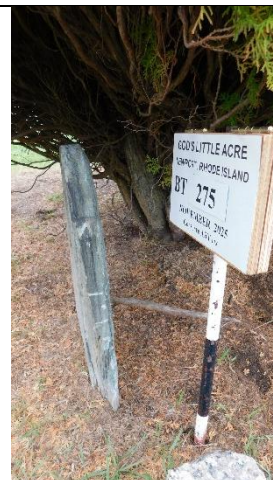
GLA 275 4. BT. PL overview.

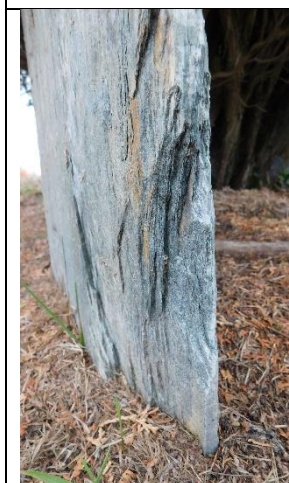
GLA 275 5. BT. PL detail of breaks.

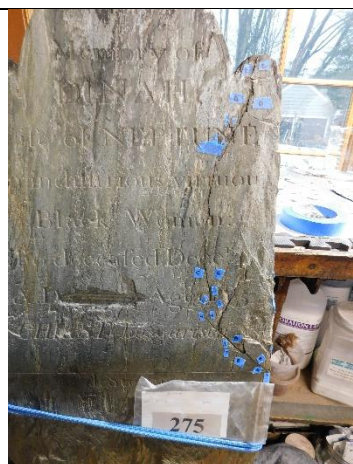
GLA 275 6. DT. Front, PL side, dry fitting fragments.

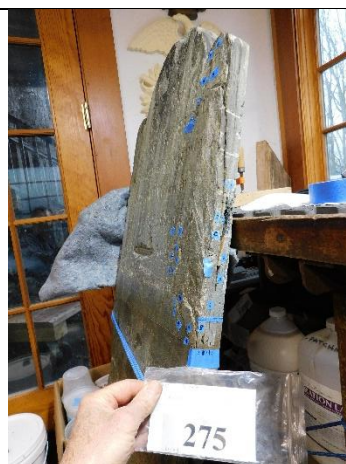
GLA 275 7. DT. PL dry fitting fragments.

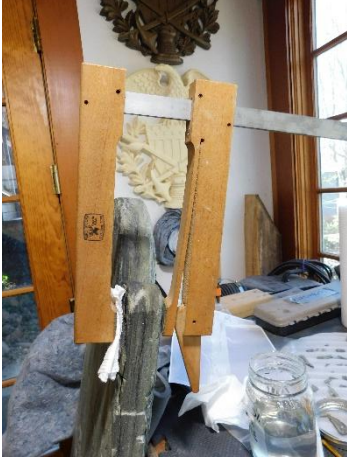
GLA 275 13. DT. Upper fragments with B-72 and clamps.

■ **Repairs:** Front face fragments with carving were reattached using 60% B-72 due to the thin layering of the stone pieces and the need to have slow cure of the adhesive.

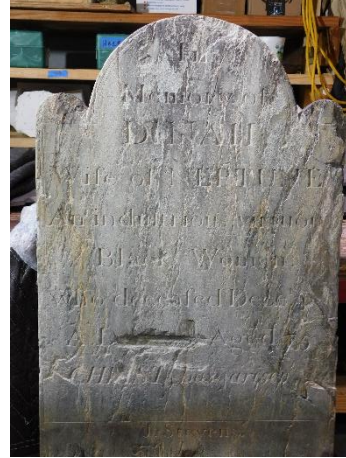
GLA 275 15. DT. Carving after fills.

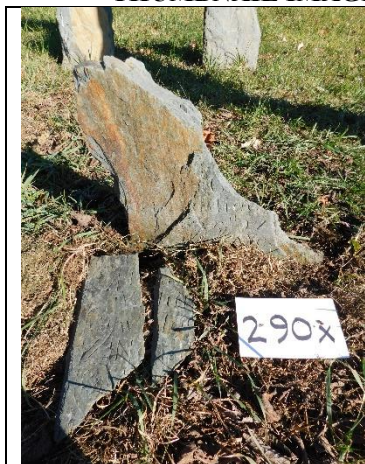
GLA 290x 1. BT. Front overview.

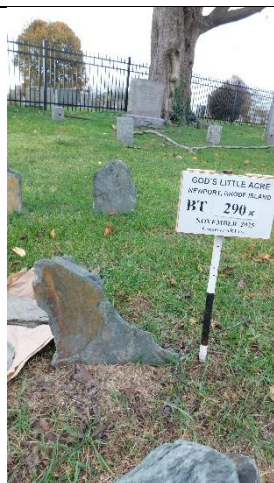
GLA 290x 2. BT. Front overview.

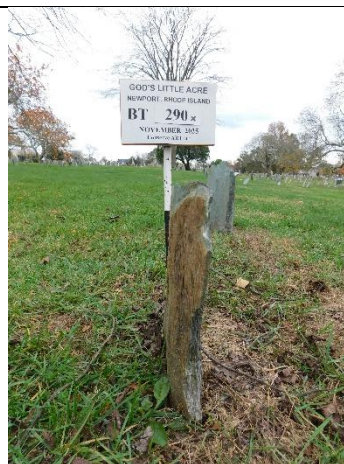
GLA 290x 3. BT. PR overview.

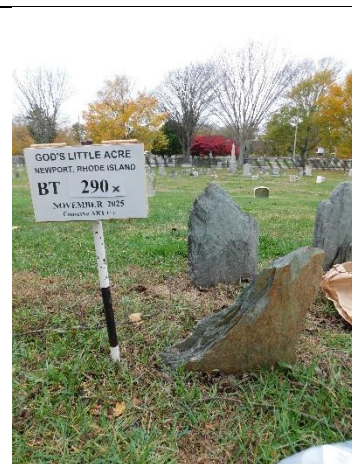
GLA 290x 4. BT. Back overview.

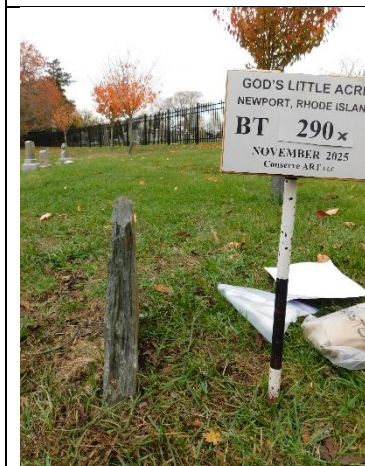
GLA 290x 5. BT. PL overview.

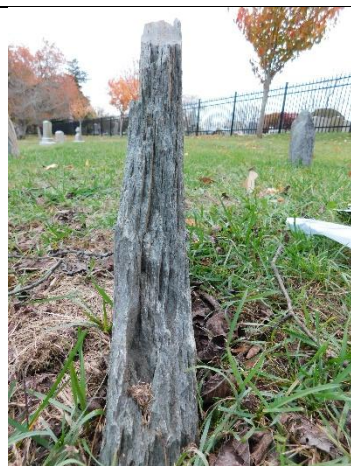
GLA 290x 6. BT. PL Detail.

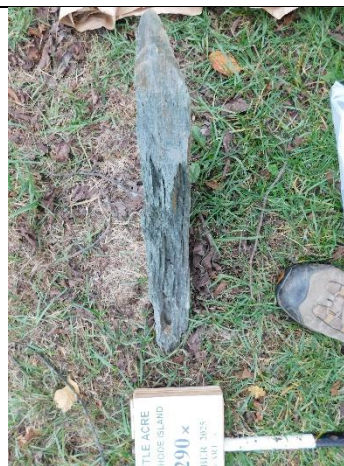
GLA 290x 7. BT. Top overview.

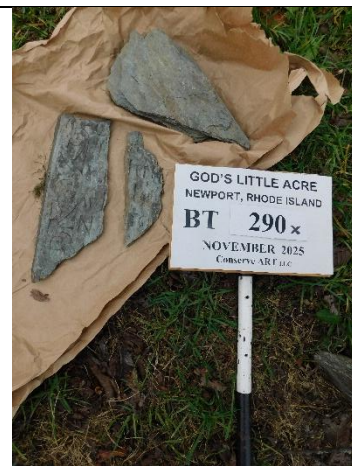
GLA 290x 8. BT. Collecting Fragments.

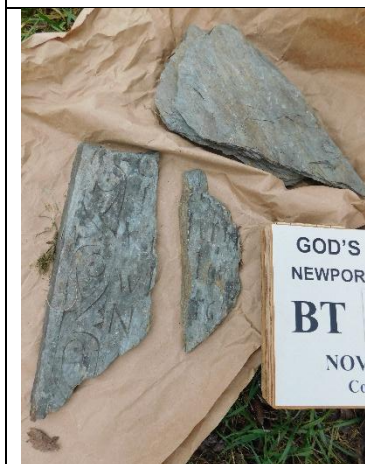
GLA 290x 9. BT. Collecting Fragments, detail.

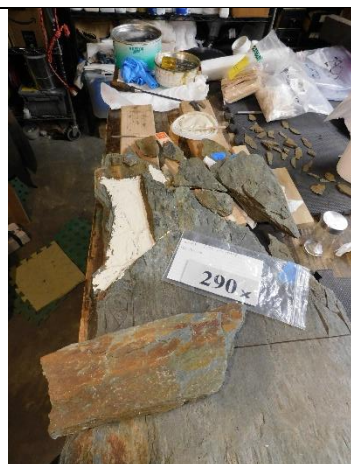
GLA 290x 10. DT. Adhering sections with Akemi Akepox 2030.

■ **Repairs:** The fragments were sorted by color, grain orientation, shape and surface quality. Due to the numerous, sheeted fragments, the fitting process was slow and incomplete. Many of the fragments without a front face finish, outer contour or other visual delineation could not be fit during the reconstruction. The pieces were dry fit and then joined with Akemi Akepox 2030 with Coloring Paste added to tint the adhesive.

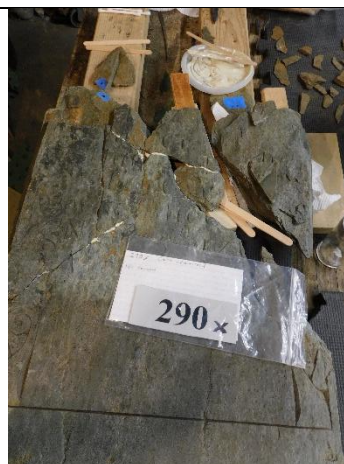
GLA 290x 11. DT. Adhering sections with Akemi Akepox 2030.

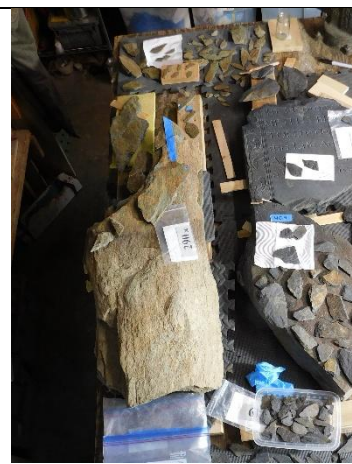
GLA 290x 12. DT. Fitting back sections and fragments.

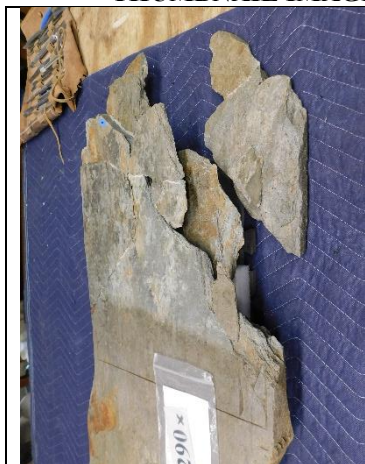
GLA 290x 13. DT. Determining orientation of fragments and sections.

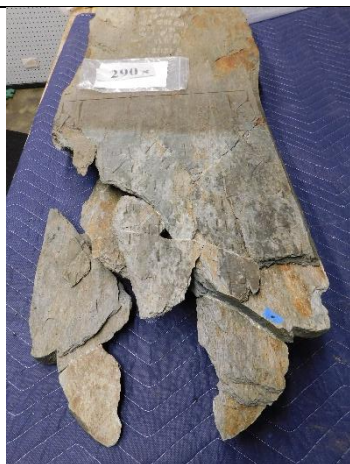
GLA 290x 14. DT. Determining orientation of fragments and sections.

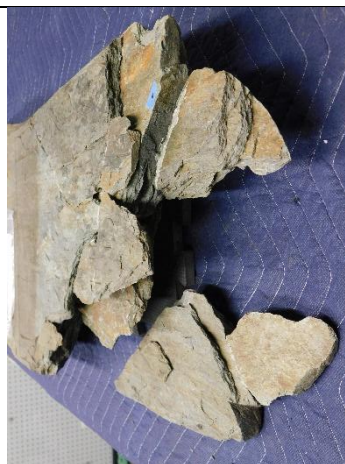
GLA 290x 15. DT. Determining orientation of fragments and sections.

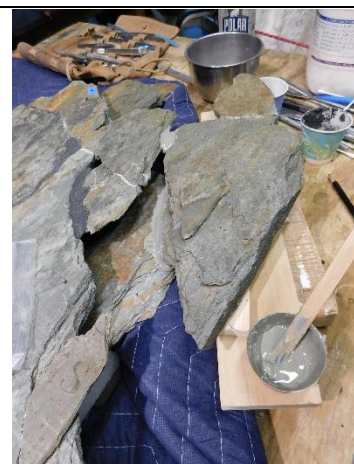
GLA 290x 16. DT. Adhering sections with Akemi Akepox 2030.

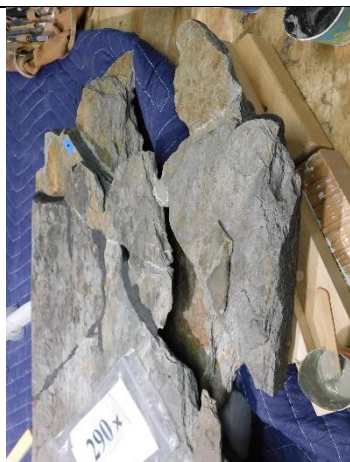
GLA 290x 18. DT. Adhering sections with Akemi Akepox 2030.

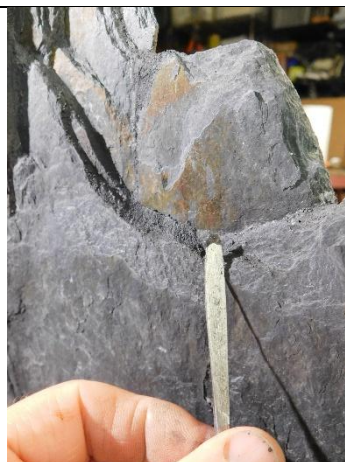
GLA 290x 19. DT. Filling mend-lines and caps with Edison Coatings Systems 45.

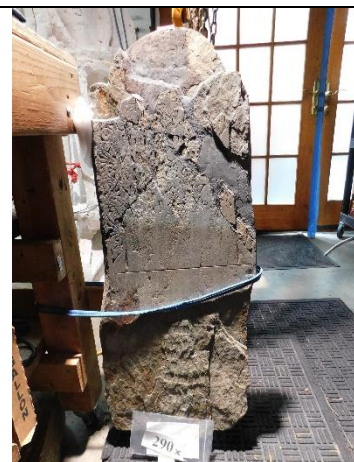
GLA 290x 20. DT. Overview of marker with fills and caps with Edison Coatings Systems 45.

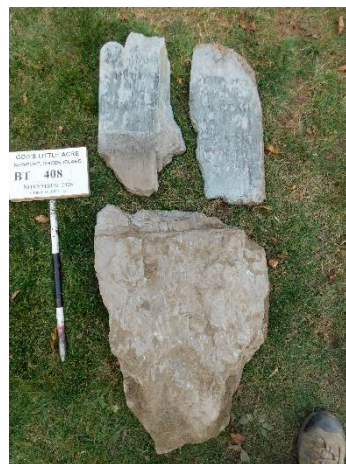
Front overview before treatment.

■ **Growth/Soiling:** The surface has only minor growths or possible attached dead growths. Small plates have root growth in the cracks below grade. Lawn clippings have adhered to the visible surfaces. Black, possible carbon deposits predominately on the top.

■ **Delamination:** The front and back have numerous micro delaminations. The micro separation has caused loss to sculptural and text detail and speckled coloration by exposing “fresh” stone in contrast to an aged surface patina.

■ **Cracks:** Cracks are formed along the delamination. Larger cracks are visible in the break locations

■ **Hazardous Alignment:** The upper carved stone is broken and fallen.

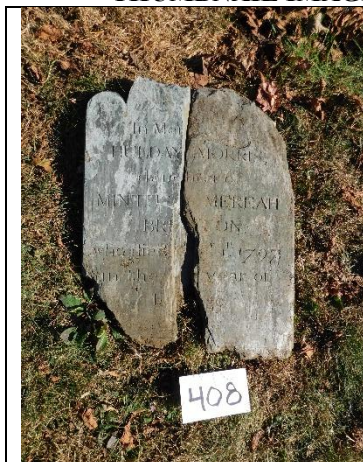
GLA 408 1. BT. Front overview.

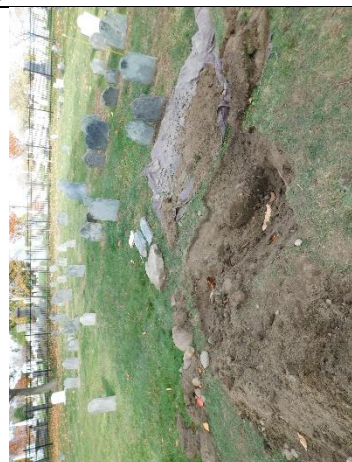
GLA 408 2. BT. Unearthing sections and fragments.

■ **Removal for Treatment:** The marker was unearthed and the area searched for fragments. Found fragments were bagged and labeled to correspond with the stone. The marker was placed in a wood crate and brought to the studio in Hamden, CT.

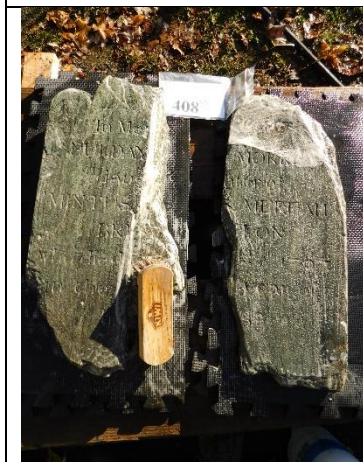
GLA 408 5. DT. General cleaning with Orvus solution.

■ **General Soiling Removal:** The surfaces were rinsed with filtered water and cracks flushed with pressurized water and syringe to remove debris, dirt and roots. The stone was cleaned with a solution of Orvus, anionic detergent, with gentle agitation using natural fiber brushes. Small grass fibers were very difficult to remove.

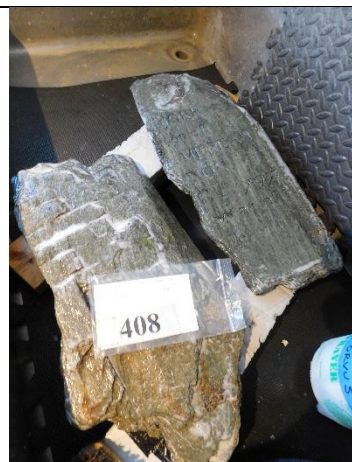
GLA 408 6. DT. Additional general cleaning with Orvus solution.

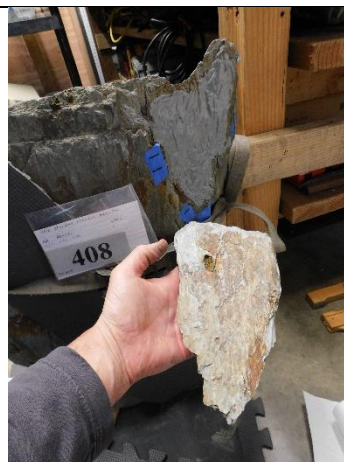
GLA 408 7. DT. Adhering fragments with Akemi Akepox 2030.

■ **Repairs:** The fragments were sorted by color, grain orientation, shape and surface quality. Due to the numerous, sheeted fragments, the fitting process was slow and incomplete. Many of the fragments without a front face finish, outer contour or other visual delineation could not be fit during the reconstruction. The pieces were dry fit and then joined with Akemi Akepox 2030 with Coloring Paste added to tint the adhesive.

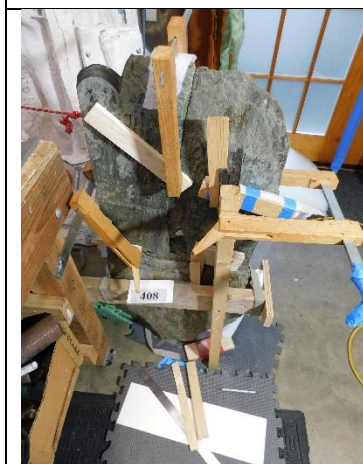
GLA 408 9. DT. Adhering fragments with Akemi Akepox 2030 and clamps.

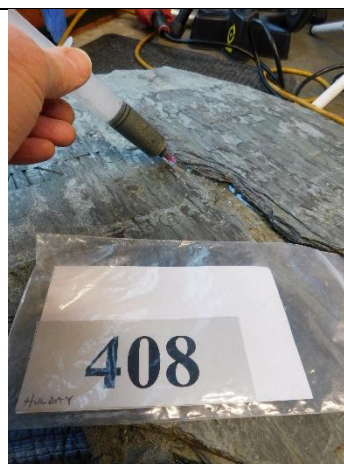
GLA 408 11. DT. Filling openings at mends with Akemi Akepox 2030.

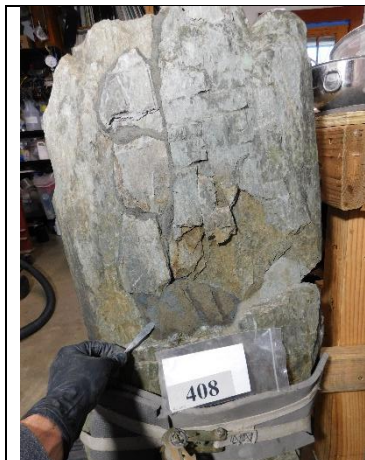
GLA 408 13. DT. Fills and caps with Edison Coatings Systems 45, slate dusts and Bayferrox pigments.

■ **Fills:** Small fills were done with 20-60% B-72 bulked with slate dusts and Cenospheres. Crack openings, mend-lines and caps to shed water were filled with Edison Coatings Systems 45 with the addition of 50% slate aggregates. The fill materials were tinted with Bayferrox pigments to blend in color with the surrounding stone.

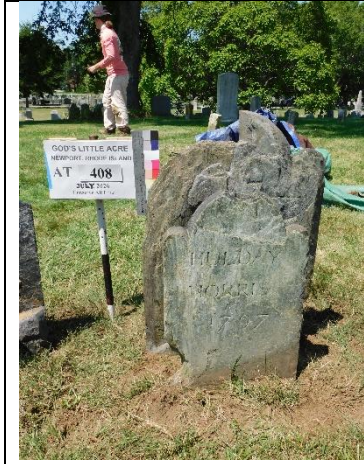
GLA 408 25. AT. Footstone set behind marker.

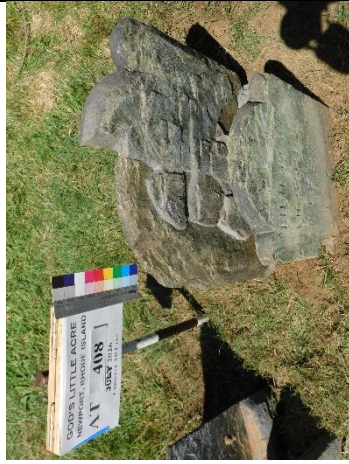
GLA 408 26. AT. Back view, looking downward with foot stone.

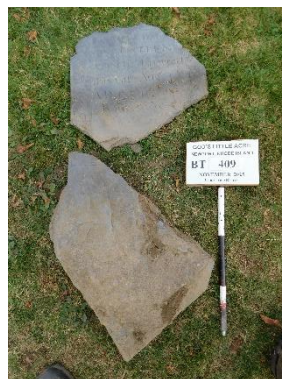
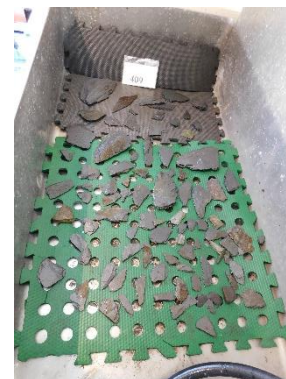
Front overview before treatment

Black slate with iron rich minerals between cleavage planes. Face primarily black, in very good condition with small orangish deposits and loss of surface detail in these areas

■ **Growth/Soiling:** The surface has only minor growths or possible attached dead growths. Small plants have root growth in the cracks below grade. Lawn clippings have adhered to the visible surfaces.

■ **Delamination:** The face is in good condition with only minor loss along cleavage anomalies.

■ **Cracks:** Minor cracks at the delaminations. Larger cracks are associated with breaks.

■ **Breaks:** The stone was broken into multiple sections, with only two major sections remaining. A break-line continues horizontally to the top of the stone above the text. A second major break-line runs from the middle of the text on the proper left side and runs diagonally to the lower proper right. A third major break-line runs diagonally from the bottom of the second break to the proper left side. There is also a substantial break/loss to the back of the stone.

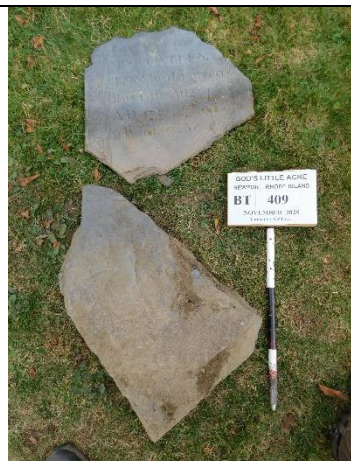
GLA 409 2. BT. Front overview with unearthed base section.

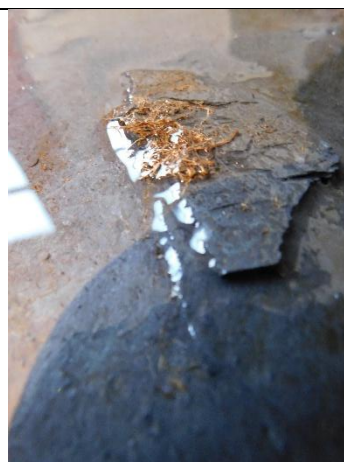
GLA 409 7. DT. Small fragment detached showing roots.

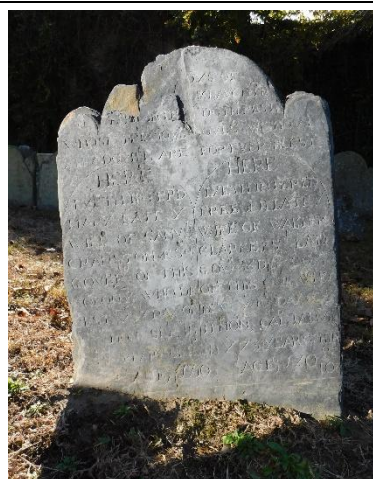
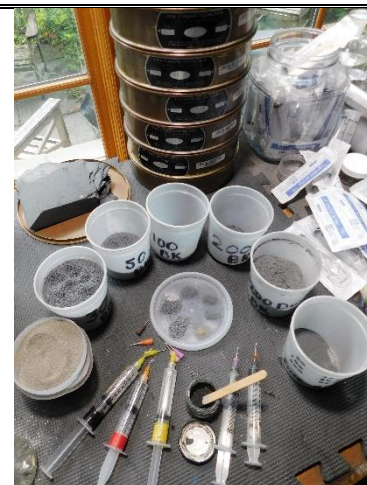
Front overview before treatment

Black slate with iron rich minerals between cleavage planes. There is minor upward cleavage dip to the back, proper right. The stone was quarried with a slight bow with the top and bottom curved forward.

■ **Growth/Soiling:** The surface has only minor growths or possible attached dead growths. Small plates have root growth in the cracks below grade. Lawn clippings have adhered to the visible surfaces. Black, possible carbon deposits predominately on the top.

■ **Delamination:** The front has small delaminations. The sides and top have larger cleavage separations, particularly at the top where the impact has caused sheeting.

■ **Cracks:** Cracks are formed along the delaminations. Larger cracks are visible on the top and sides, particularly at impact points and breaks. A crack migrates downward in the center to the stone face from the impact.

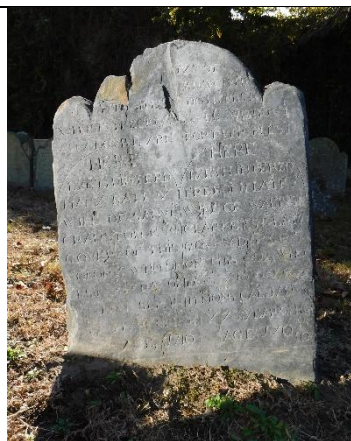
CBG MC-FC 2. BT. Front overview.

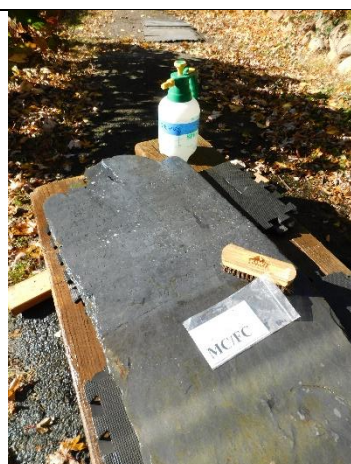
CBG MC-FC 10. DT. General cleaning with Orvus solution.

■ **General Soiling Removal:** The surfaces were rinsed with filtered water and cracks flushed with pressurized water and syringe to remove debris, dirt and roots. The stone was cleaned with a solution of Orvus, anionic detergent, with gentle agitation using natural fiber brushes. Small grass fibers were very difficult to remove.

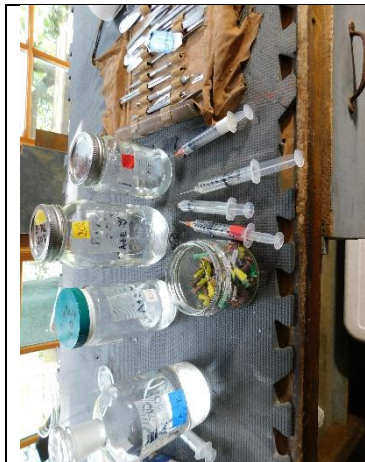
CBG MC-FC 13. DT. B-72 solutions mixed for injections.

■ **Crack Injection:** Cracks were cleaned as possible and the stone allowed to dry for 2-3 weeks. Injections were made with B-72 with the addition of slate dusts and ceramic microspheres for larger openings. Micro cracks on the face were injected as well as larger cracks on the face and the sides. Extensive injections were made in the large cleavage plane cracks.

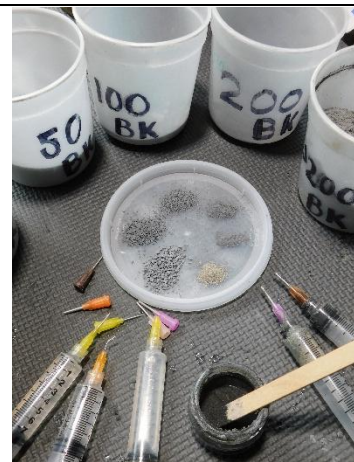
CBG MC-FC 16. DT. B-72 solutions and bulked with state dusts and ceramic spheres detail.

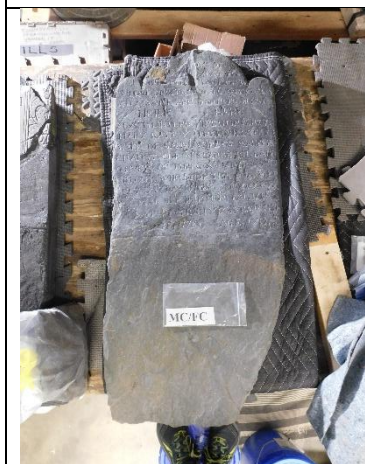
CBG MC-FC 21. DT. Overview of marker after injections and fills.
